INSPECTION REPORT

For the Property at:
000 ANY STREET
ANYTOWN, MB

RE: Report No. 2254
000 Any Street
Anytown, MB

As per your request, an indoor air quality/mold investigation was carried out at 000 Any Street, Anytown, MB on April 1, 2013. It is our understanding that this investigation was requested due to general air quality and mold concerns and related health issues of the occupants of the house.

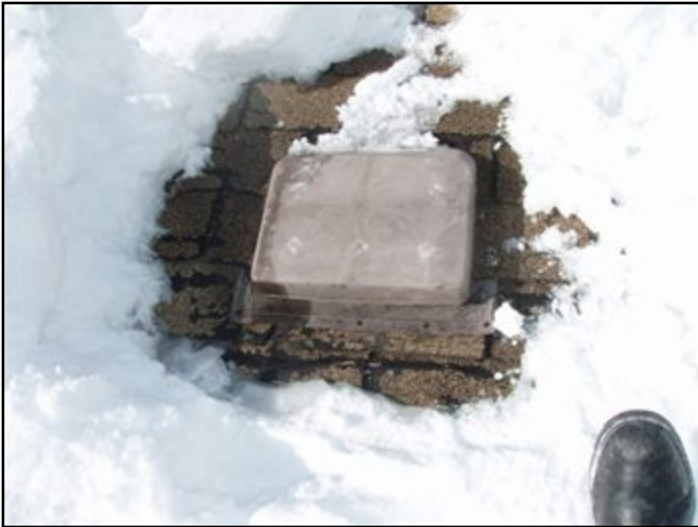
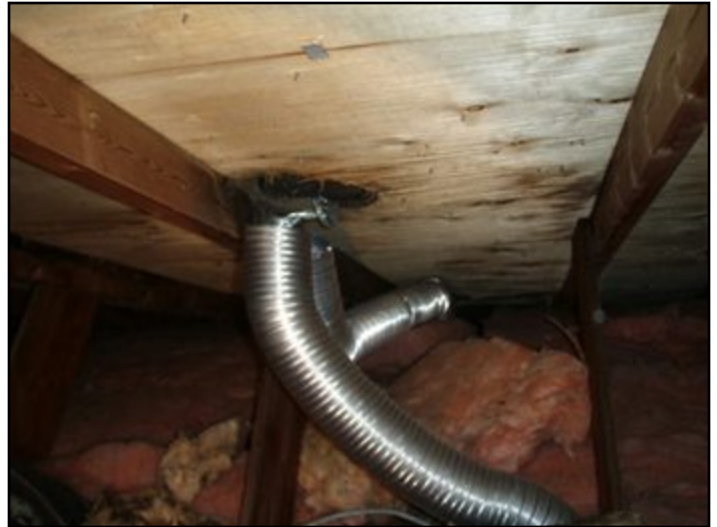
SLOPED ROOFING \ Asphalt shingles

Condition: • Near end of life expectancy

Roof shingles are at the end of life expectancy, leakage to attic observed at chimney and vents, granule loss, curling/cupping, recommend immediate replacement. Check all flashings when reroofing, repair/replace as required. Install drip edge flashing and ice/water shield when reroofing. Repair/replace moisture damaged sheathing as required when reroofing.

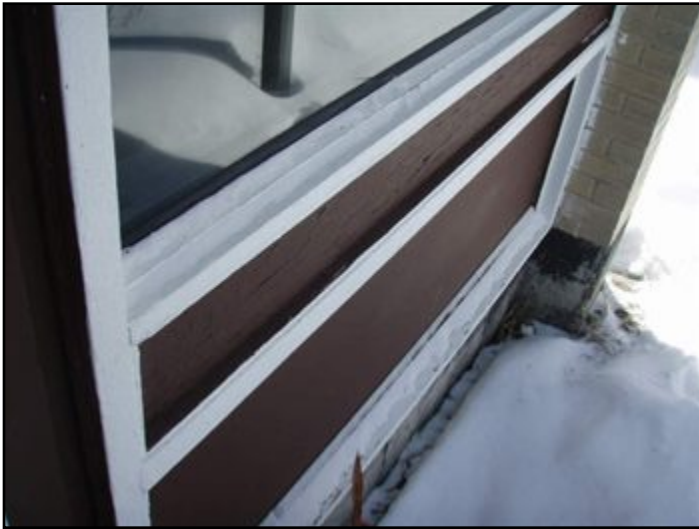
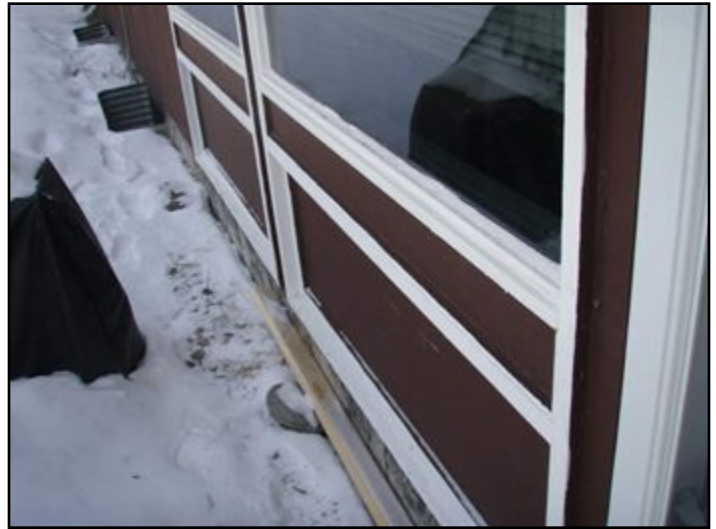
WALLS \ Plywood, hardboard, and OSB

Condition: • The exterior finishes under windows are in poor condition, lots of air leakage/deterioration in these areas, repair/replace as required.

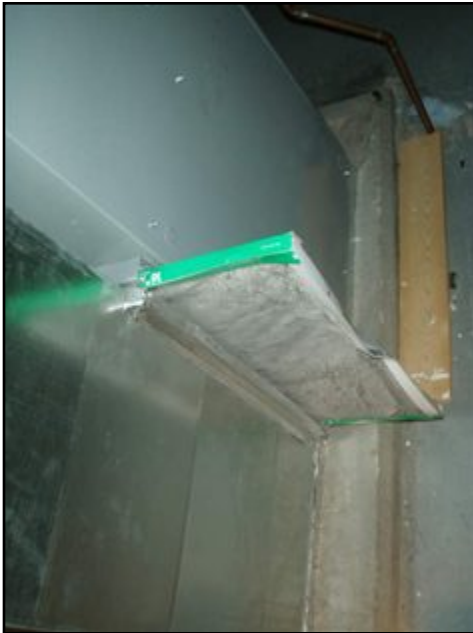
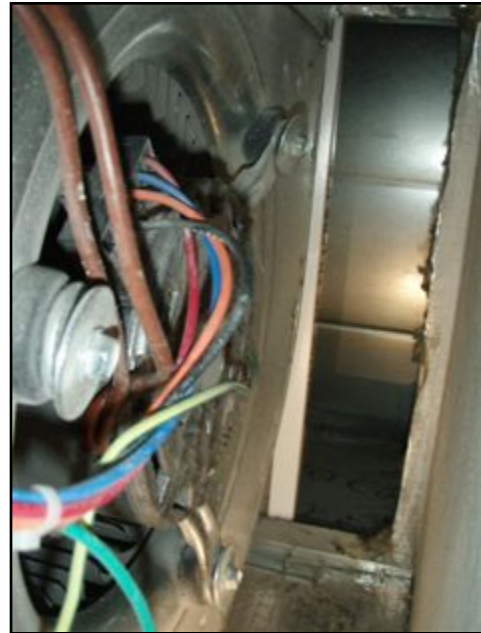
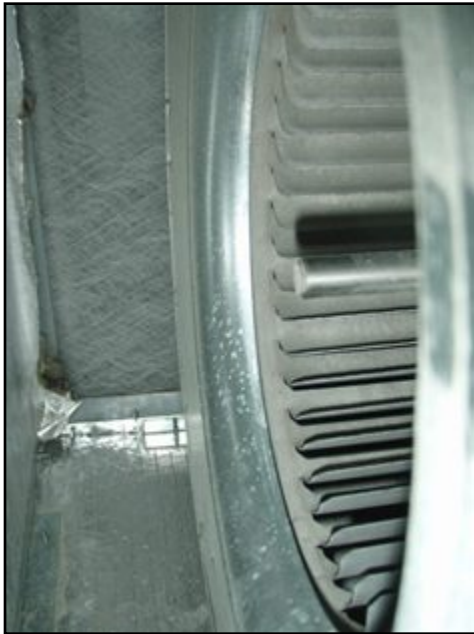
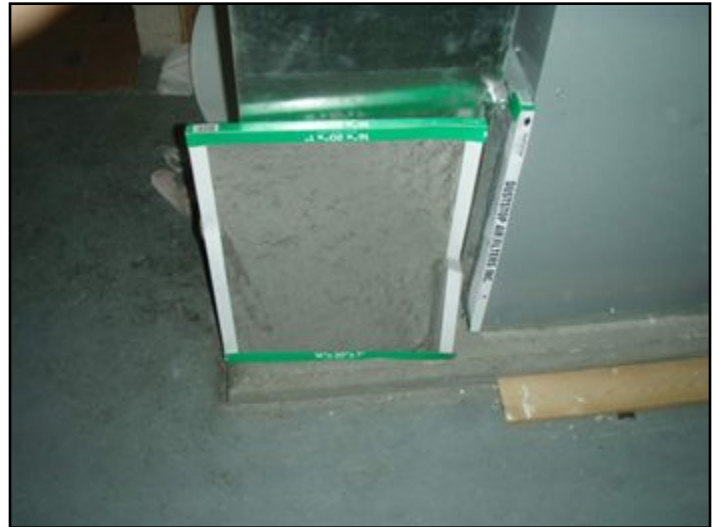
ELECTRIC FURNACE \ General

Condition: • The furnace filter installed in the filter rack is not the right size not type. The filter is clogged and the furnace blower/motor are very dirty. Recommend cleaning/servicing furnace, install proper sized/pleated type filter. In light of the ongoing use of the wrong filters and condition of furnace, it is also recommended to clean all furnace ducts in the house. The A/C evaporator coil is probably clogged with dust/dirt and severely restricting air flow/circulation, inspect/clean coil as required when cleaning ducts and furnace. Reminder to change filters every 2-3 months and service/clean furnace annually.

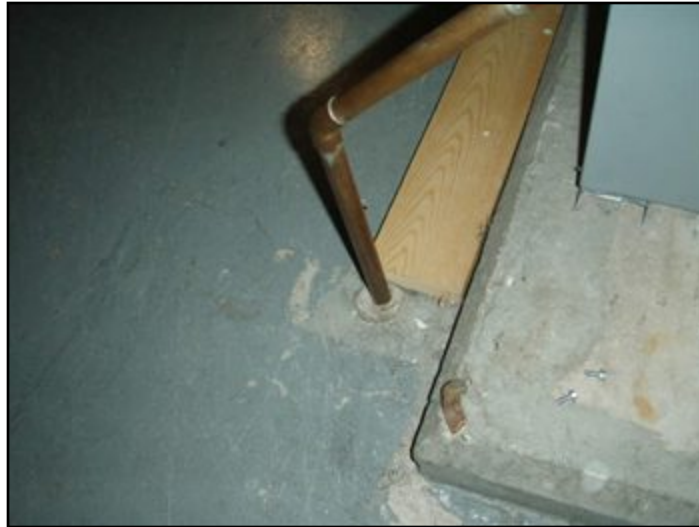
AIR CONDITIONING \ Condensate drain line

Condition: • Improper discharge point

The A/C condensate drain line is draining to under floor slab. This is not recommended as this adds moisture under the floor slab and contributes to increased moisture in basement as the moisture under the slab is continually wicking up through the slab and increasing humidity levels in basement. The condensate drain should drain to the floor drain or plumbing system in basement.

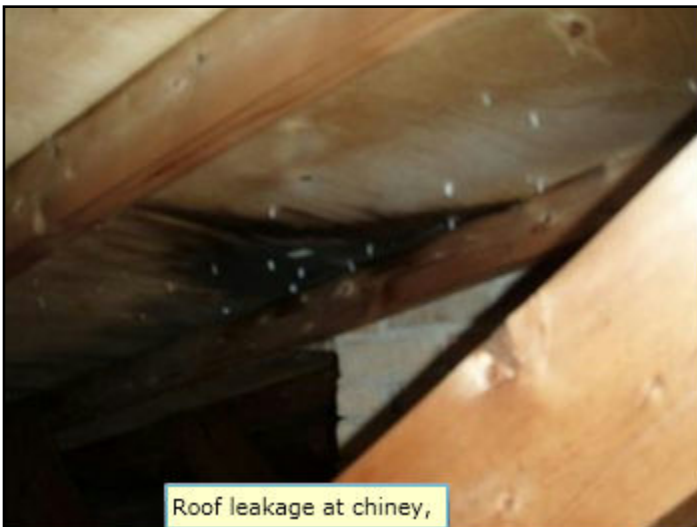
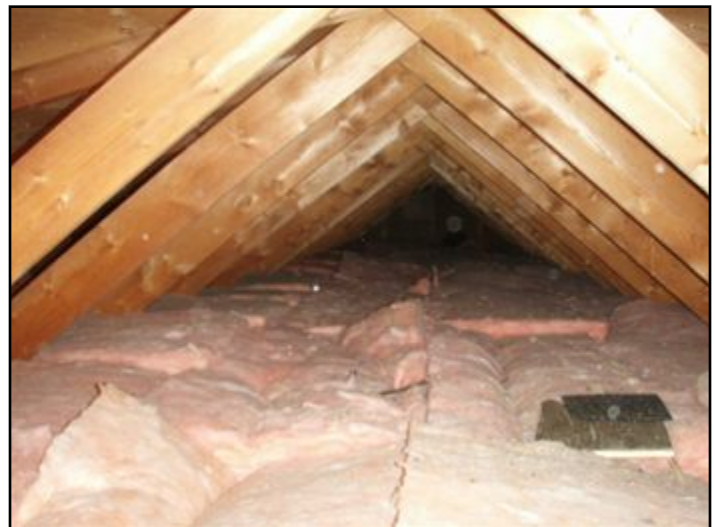
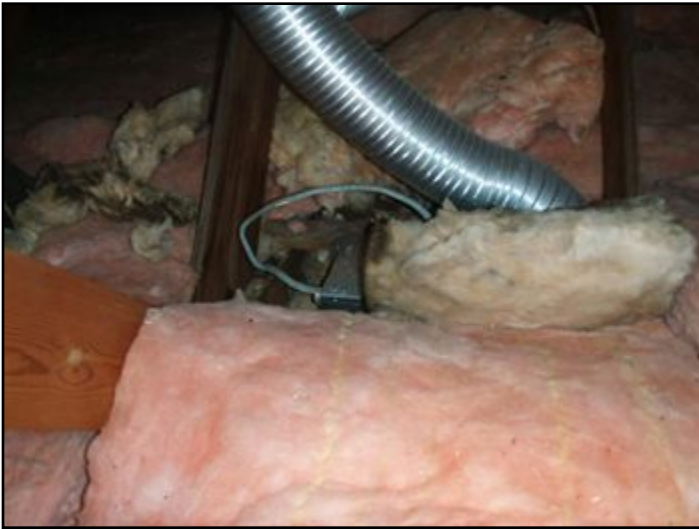
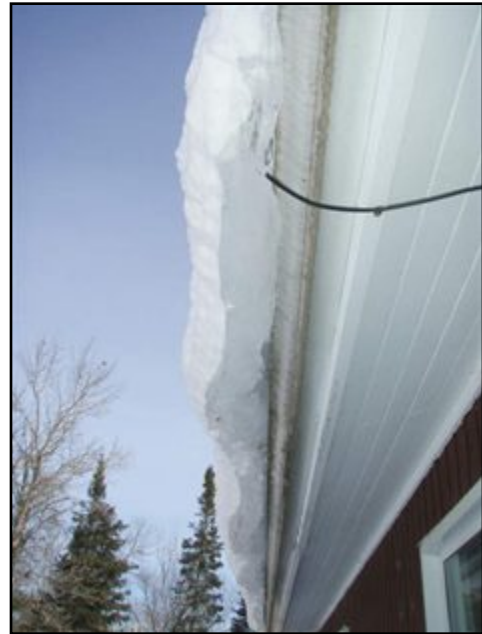
ATTIC/ROOF \ Air/vapor barrier

Condition: • Air leakage excessive

Ice damming observed at roof edges at front and rear. This condition is usually indicative of excessive indoor air leakage to attic space. There were insulation , frosting and water leakage observed in attic at time of inspection. Exhaust fans are not properly installed and venting to attic is significantly contributing to the leakage. Replace exhaust fans in bathrooms and kitchen, replace exhaust ducts with proper insulated ducts which terminate to outside, remove/replace all wet insulation as required, air seal all attic/ceiling penetrations to reduce air leakage.

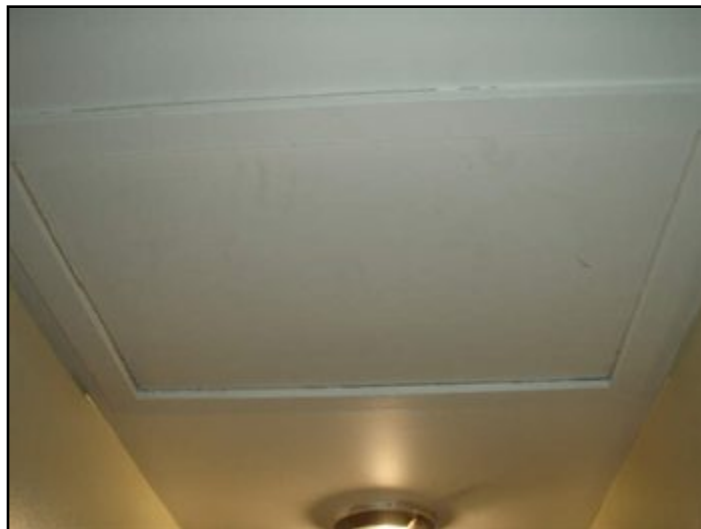
ATTIC/ROOF \ Hatch

Condition: • Not insulated and not weatherstripped

Recommend weatherstripping/insulating hatch to reduce indoor air leakage/heat loss to attic.

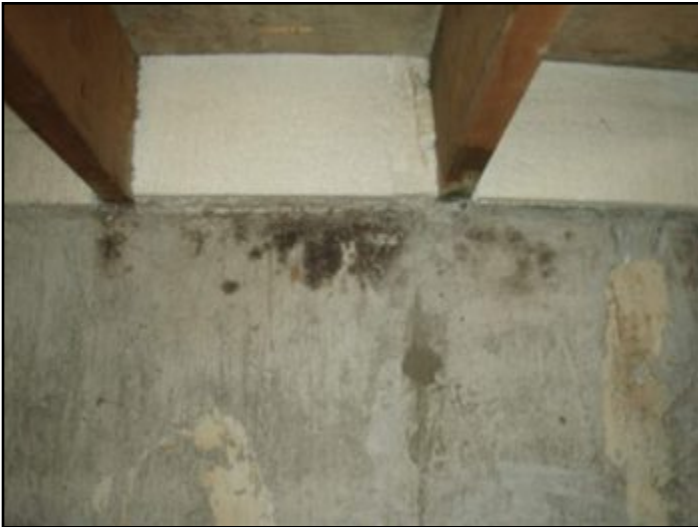
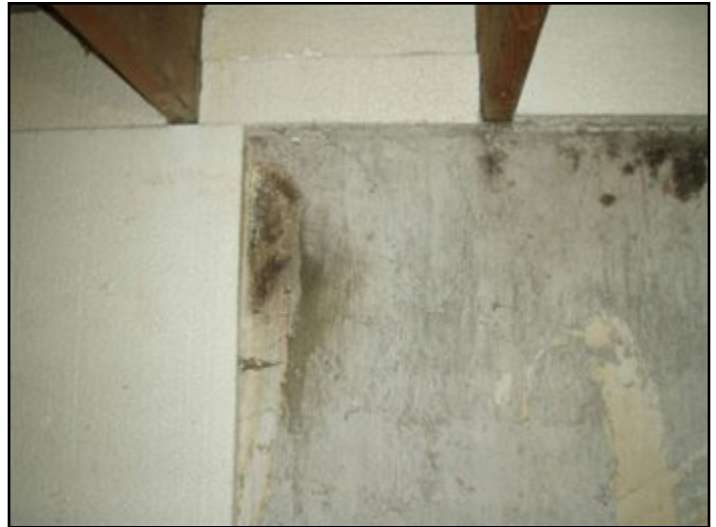
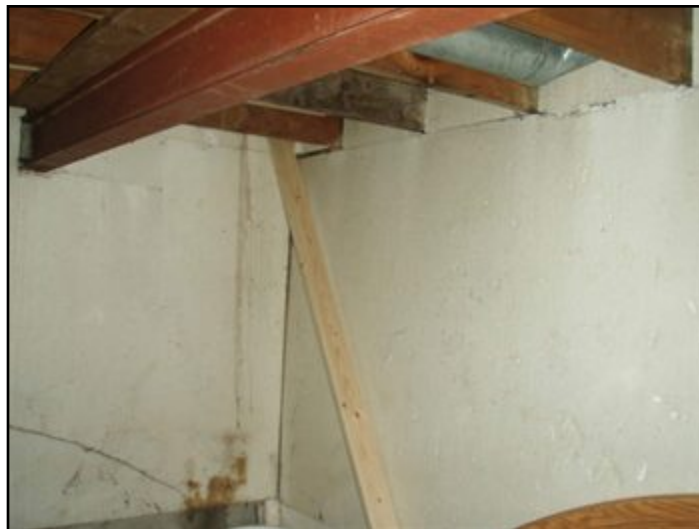
FOUNDATION \ Interior insulation

Condition: • The rigid foam insulation installed on the foundation walls is the wrong type and insufficient thickness for this application as air leakage is occurring through the insulation resulting with condensation/frosting/moisture and mold behind insulation and on concrete wall. Recommend removal of all foam insulation, clean/wash mold as required. In light of visible mold observed on walls, this work may be best done by experienced mold remediation contractor.

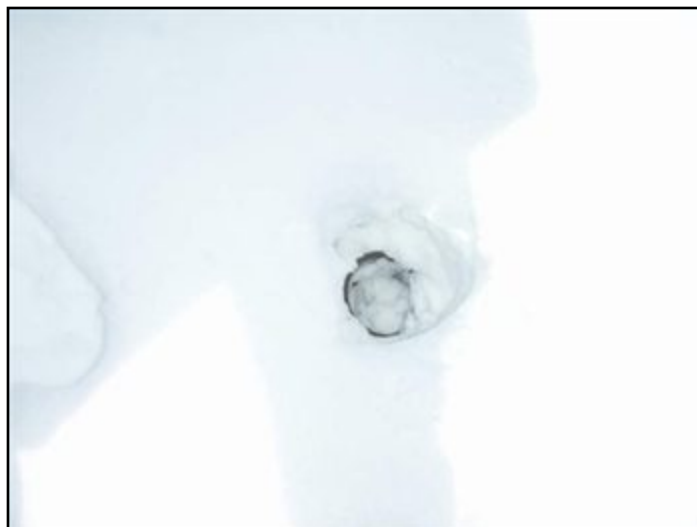
WASTE PLUMBING \ Venting system

Condition: • Insulate plumbing vent in attic. In an effort to prevent the plumbing vent from freezing at the roof, it is recommended to have your insulation contractor insulate the vent pipe in the attic space. At the time of inspection the vent was completely blocked by ice. Sewer gas can occur in the house when vents cannot operate due to blockage. See attached CMHC publication, How to Prevent Plumbing and Heating Vent Stack Freeze-Up.

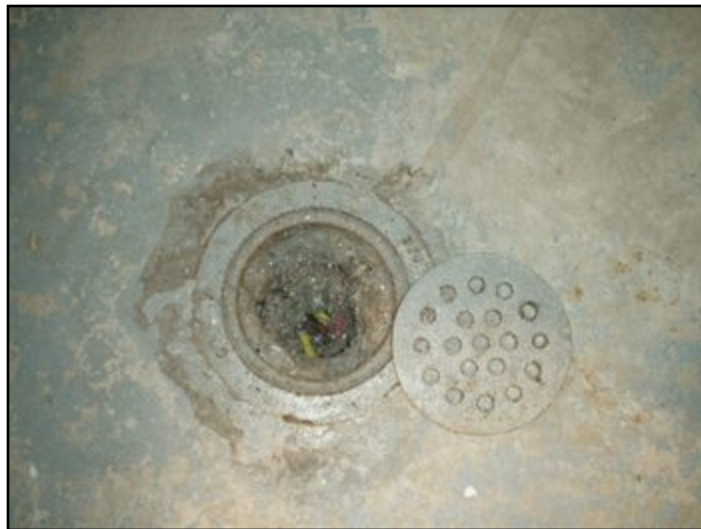
WASTE PLUMBING \ Floor drain

Condition: • Reminder to flush/prime unused basement plumbing to ensure that water does not evaporate in traps (This includes floor drains, shower drain, laundry tub, sinks, toilets, etc.). Dry plumbing traps could allow sewer gas in the house and could significantly contribute to very poor indoor air quality.

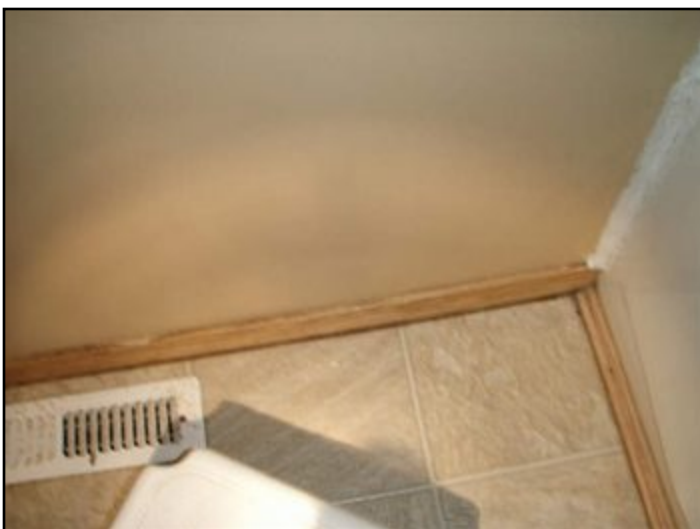
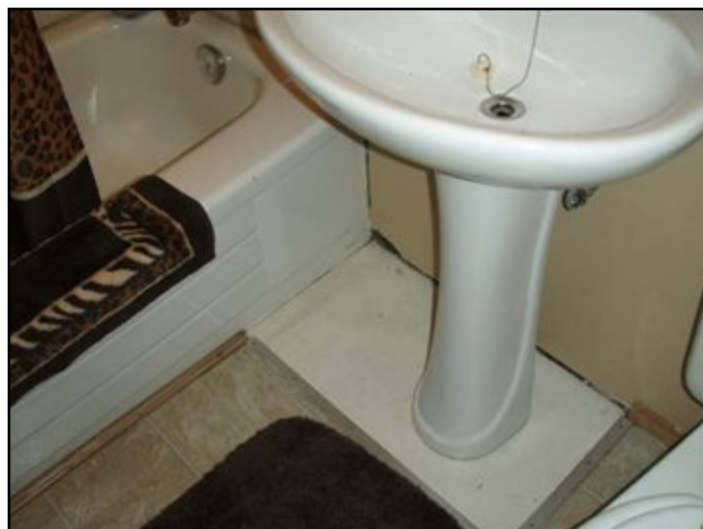
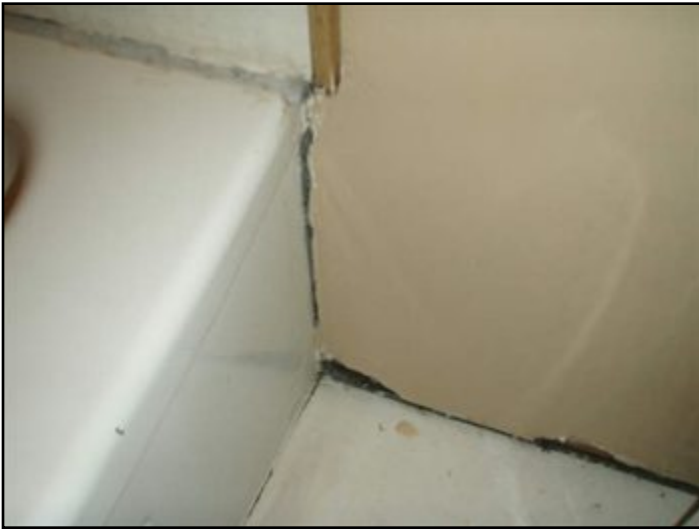
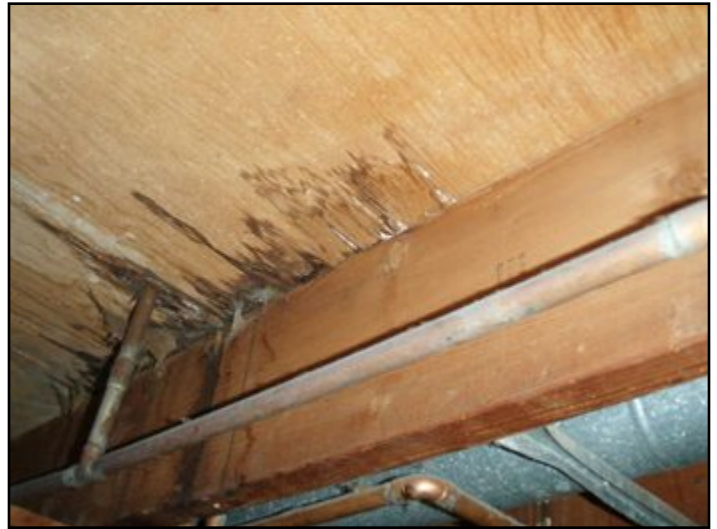
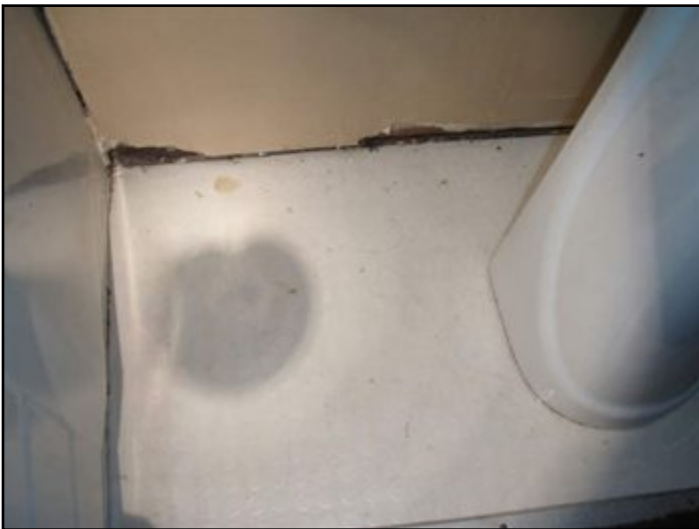
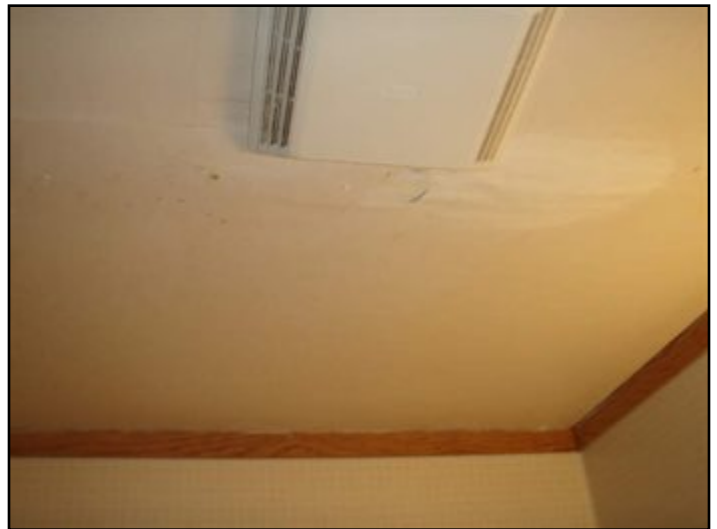
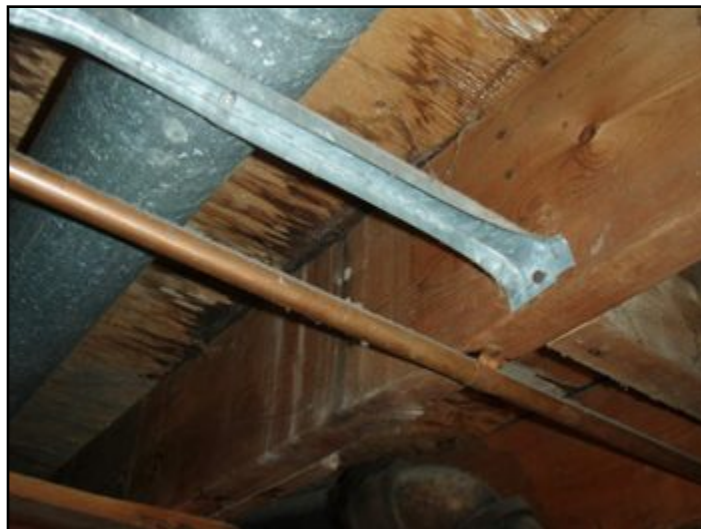
• There is considerable water leakage occurring from bathtub ledge and exhaust fan, moisture damage and mold observed to ceiling, walls, floors and finishes, recommended gutting bathroom, to framing, repair/replace framing/sheathing/finishes as required. This area is probably contributing to high mold counts on first floor.

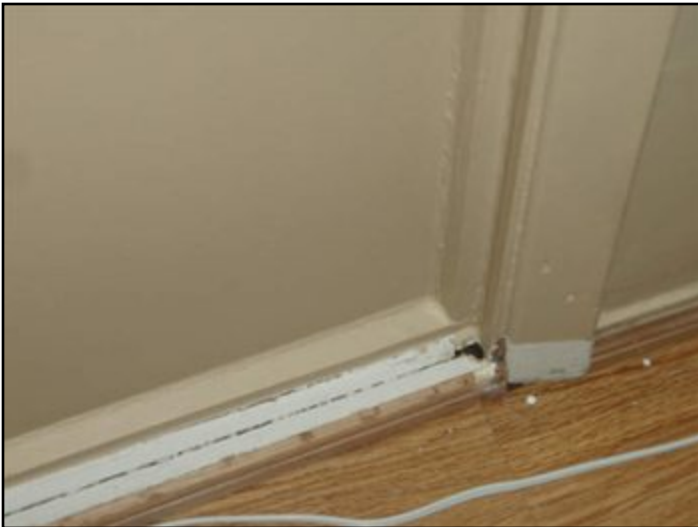
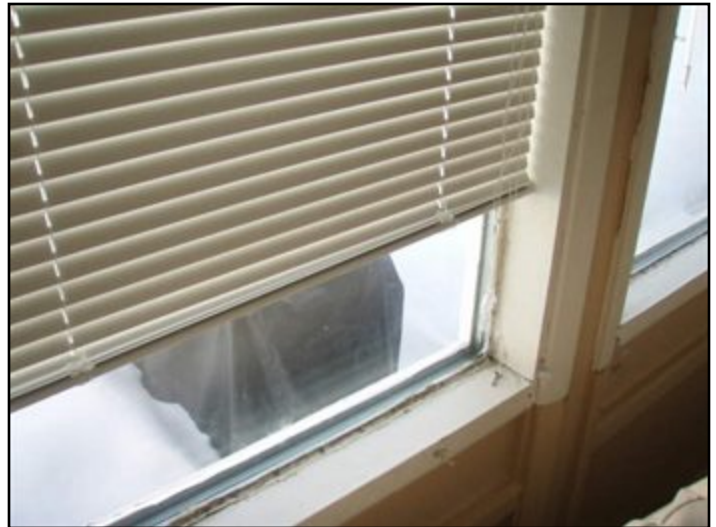
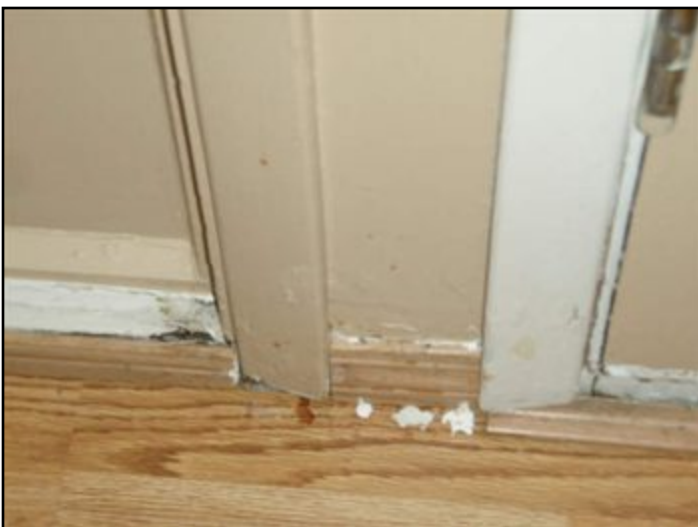
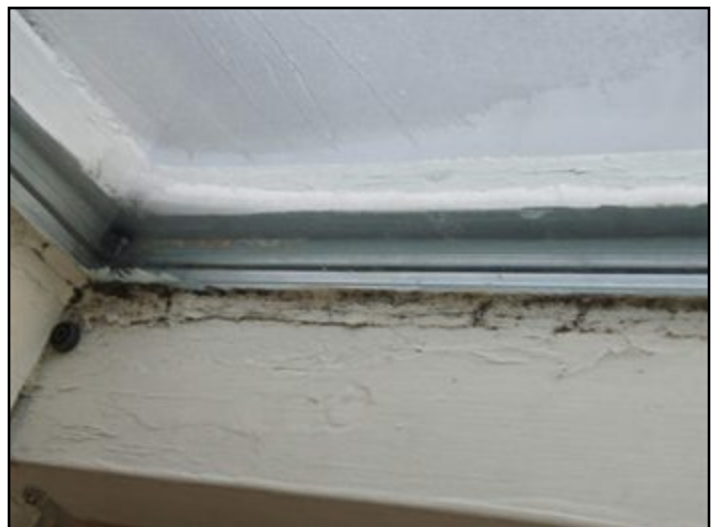
- Clean mold from windows and trim as required. Repair/seal wood finish/trim under windows, some air leakage/mold observed under windows in living & dining room.

Window coverings should be opened during the day to allow air to circulation around windows. There is a lot of condensation occurring at all windows due to poor circulation and excessive humidity.

It is further recommended to purchase and utilize a digital hygrometer to monitor the humidity levels in the house, try to maintain at 30-40% and lower during cold winter spells. High humidity levels promote mold growth and it is important to monitor the humidity levels with a good hygrometer. Hygrometers are available at major home improvement centers.

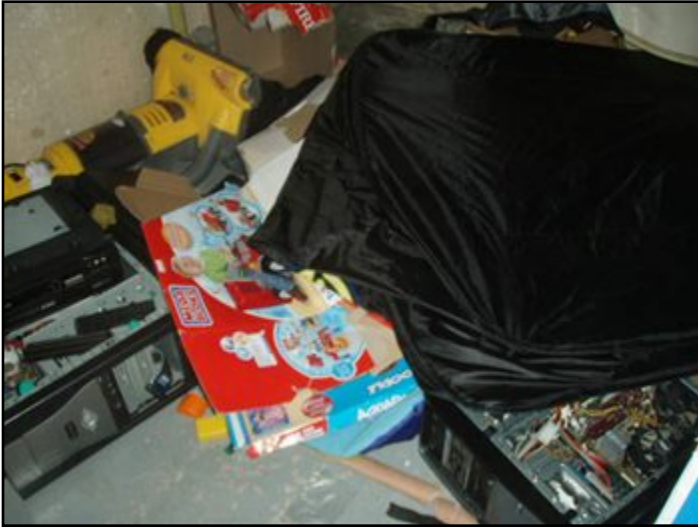
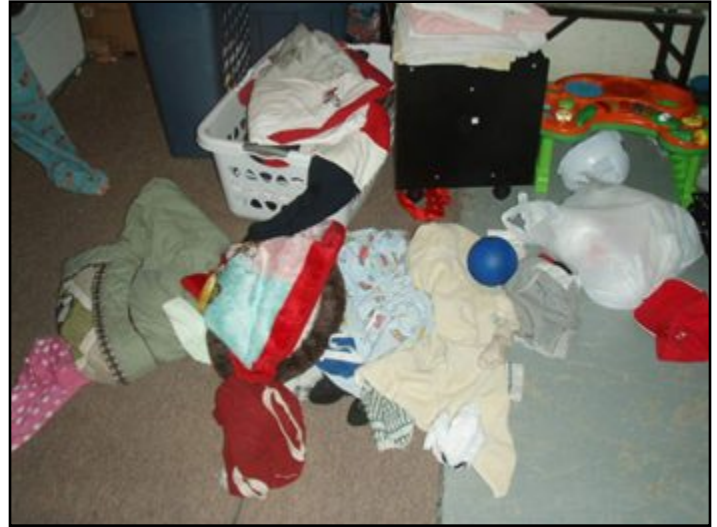
- Sort through and remove unnecessary stored materials in basement. Cardboard boxes and other materials stored on the damp floor or against exterior walls inhibit air circulation and, when damp, provide food for potential mold growth. Discard any unnecessary stored materials. Retained items in the basement should be stored in plastic containers with tight-fitting lids, off the floor and away from the walls. This keeps stored items drier and allows for better air circulation, which in turn minimizes mold growth potential. For further information see attached CMHC About Your House fact sheet, Fighting Mold: the Homeowners' Guide.

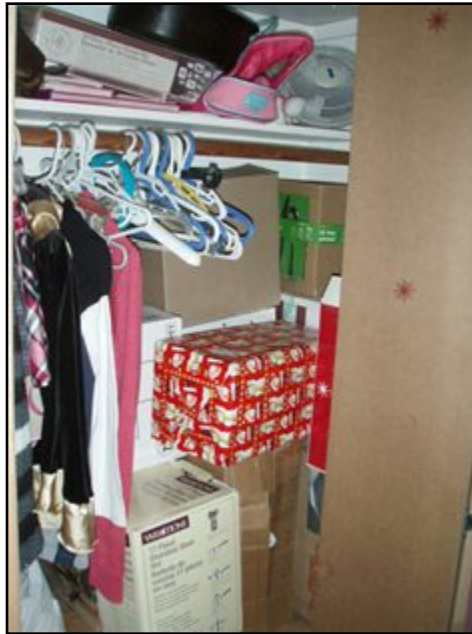
- Reduce storage in all first floor closets. It is recommended to keep clothes and storage away from exterior walls to allow air circulation. Air circulation is critical in helping prevent mold from occurring on exterior walls.

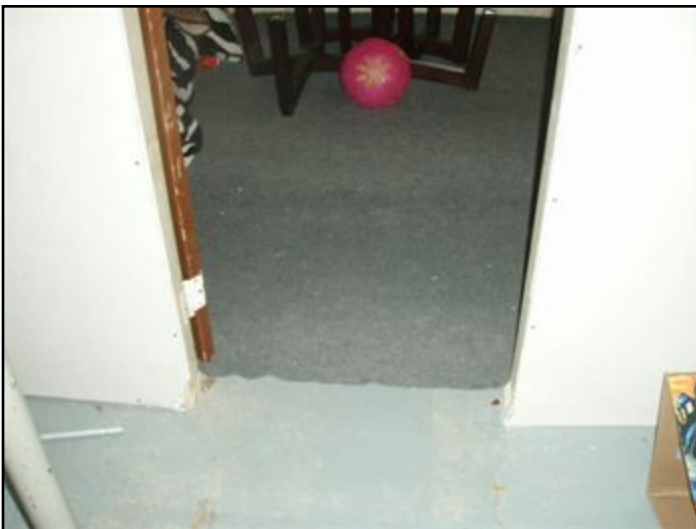
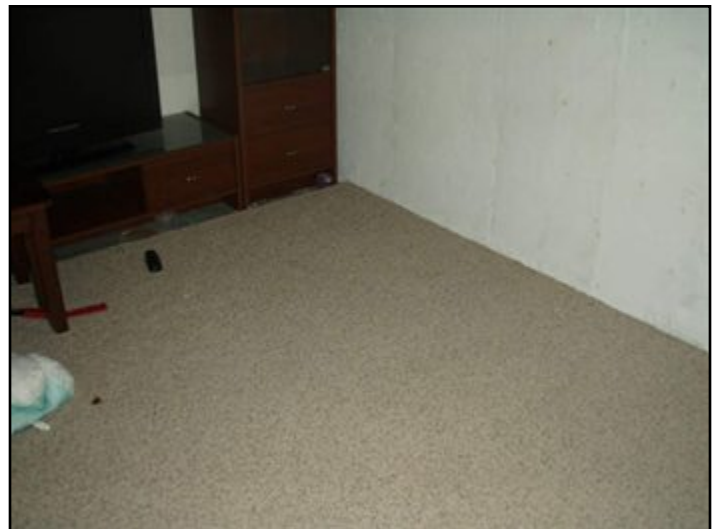
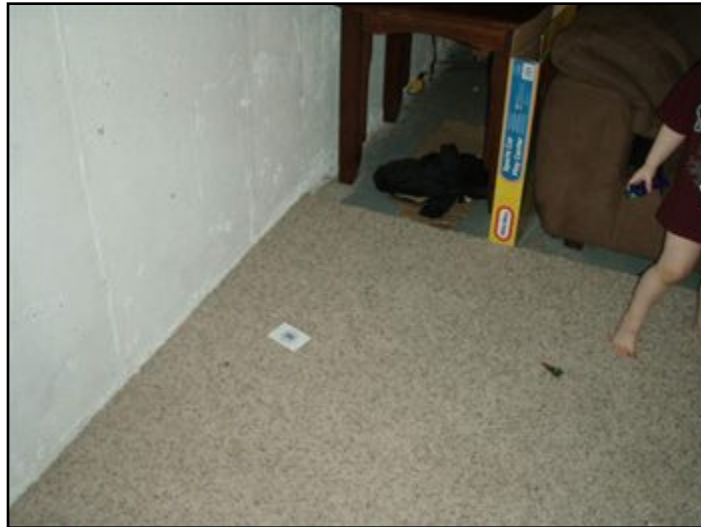
FLOORS \ Carpet on floors

Condition: • Remove carpet from the basement family room and bedroom. Concrete floors in older homes such as yours have no moisture barriers installed under the concrete floor to prevent moisture from moving upwards through the floor and coverings. As such, carpets on basement floors can wick and hold moisture and provide opportunities for mold growth. Better concrete floor finishes for these areas include low-toxicity water-based paint, composite tile or ceramic tile. Wash clean floors after removing carpet. For further information, see attached CMHC About Your House fact sheet, Flooring Choices.

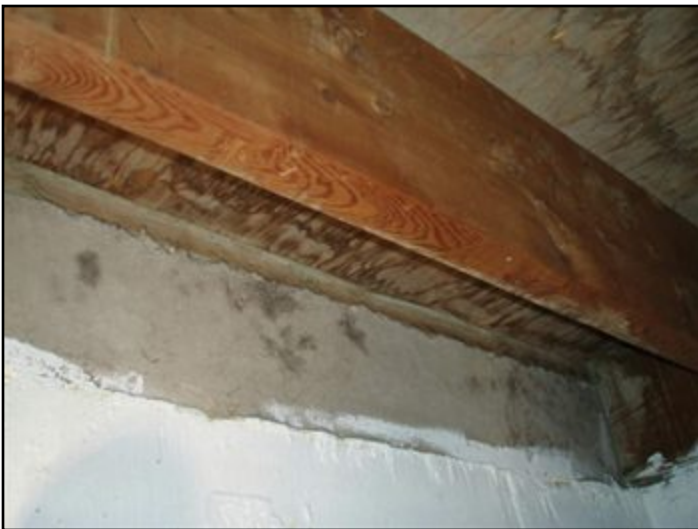
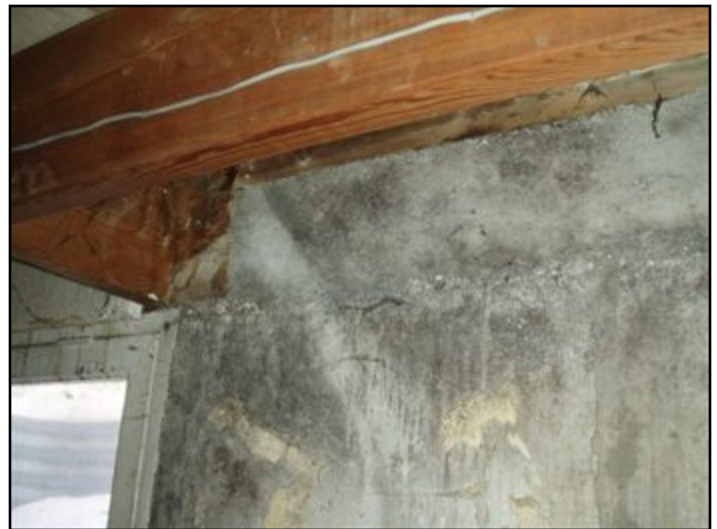
WALLS \ General

Condition: • Clean/wash all visible mold on concrete walls after all foam insulation has been removed.

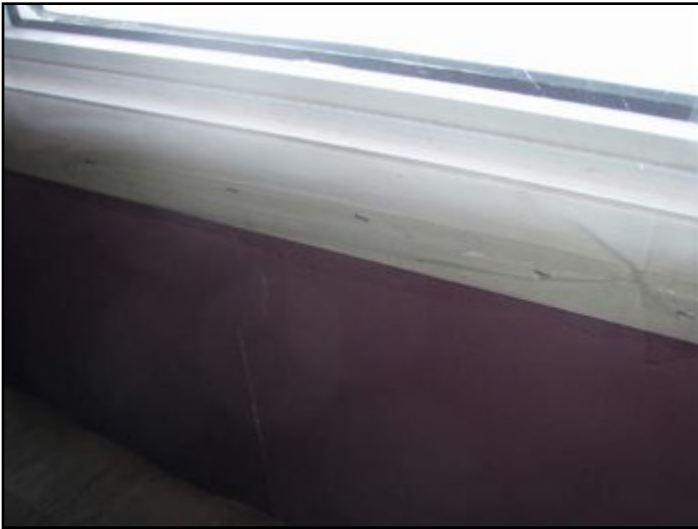
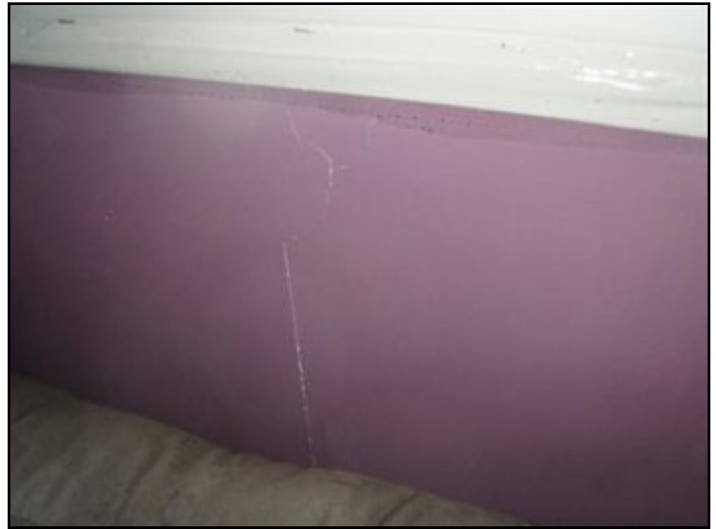
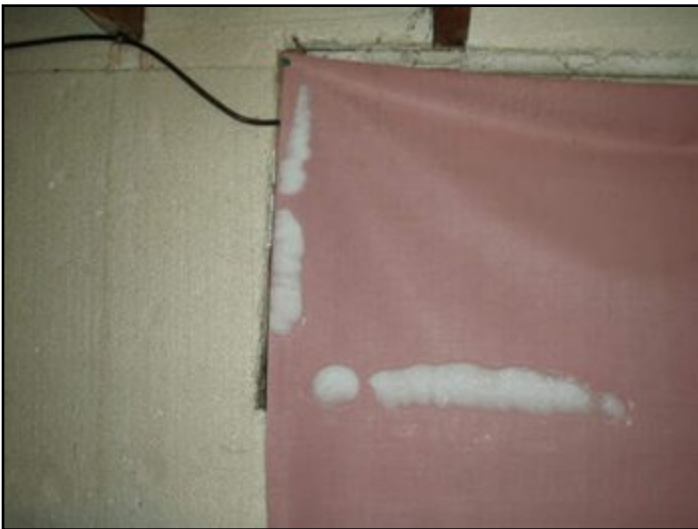
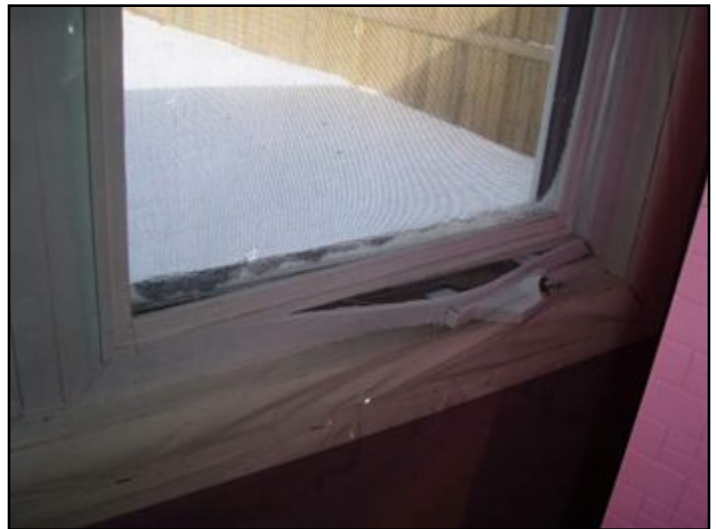
WINDOWS \ General

Condition: • Repair/replace damage window in bedroom, check insulation and framing under this window for moisture damage, repair as required.

Basement windows are leaking, repair/replace as required.

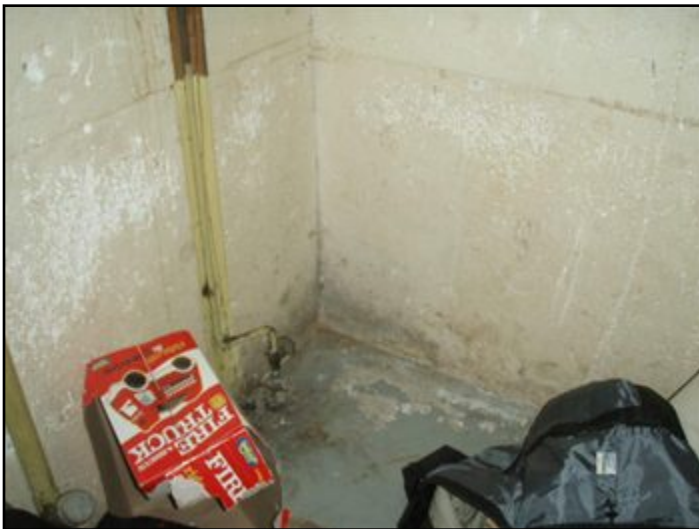
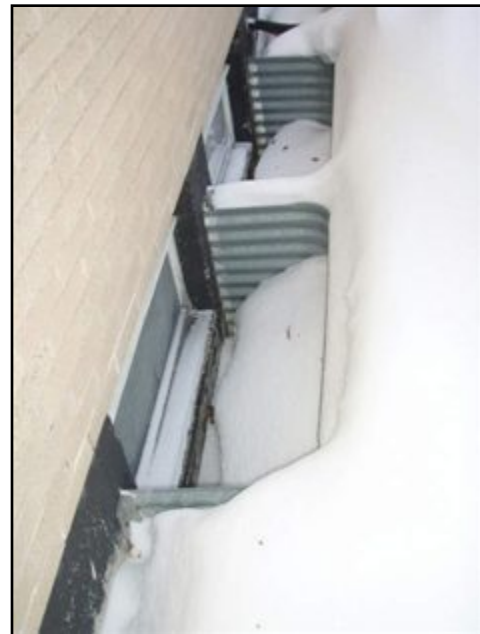
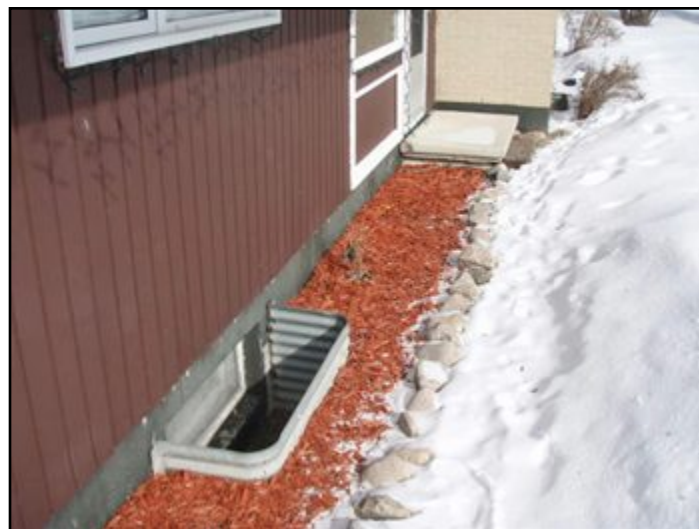
BASEMENT \ Wet basement - evidence

Condition: • Mold

Recommend evaluation of window well drains by foundation repair specialist, repair/replace/provide as required to stop water leakage under window frames due to flooded wells.

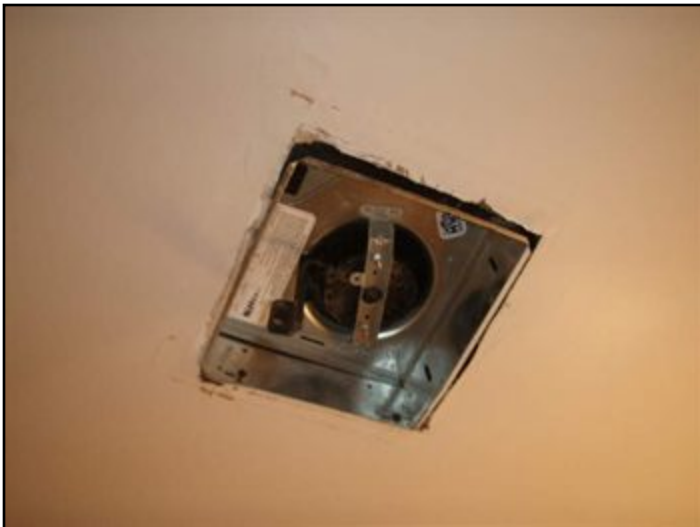
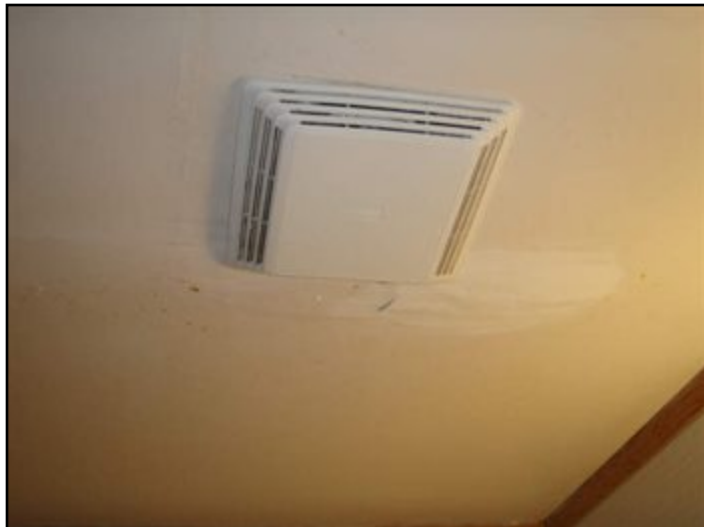
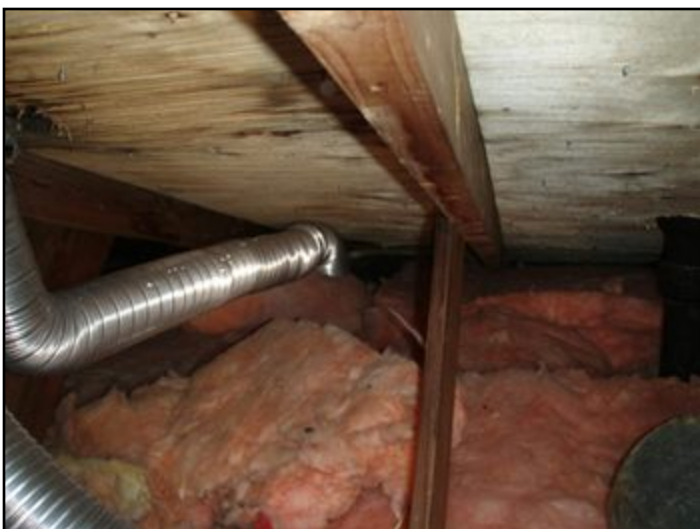
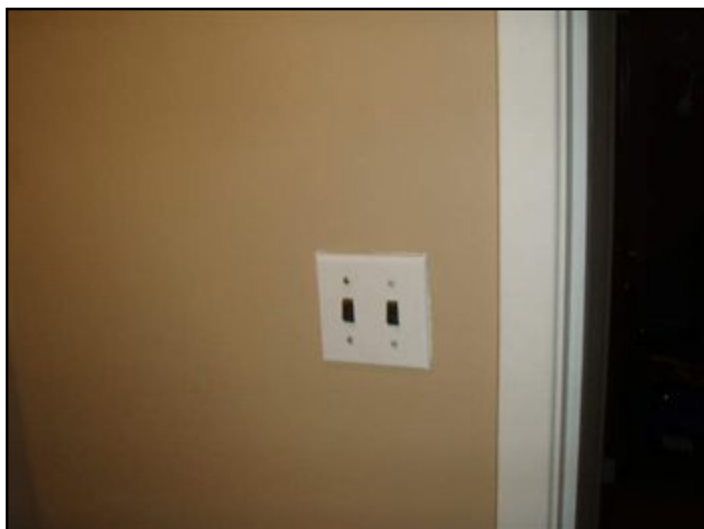
EXHAUST FANS \ Exhaust fan

Condition: • Replace lower quality/noisy exhaust fans in first floor bathrooms. The bathroom fans installed in the first floor bathrooms do not provide adequate suction to properly remove humidity and are venting in the attic. Reminder to properly seal fan housing in attic and install proper ducting to vent fans directly to the outside. Bathroom exhaust fans are critical to exhaust humid air when bathing or showering. Fans should have a capacity between 50-90 CFM (cubic feet per minute) and a sound rating of 1.5 sones or less (the lower the quieter). It is also recommended to replace the first floor exhaust fan ducting with properly sized flexible insulated ducting made for this purpose. A contractor should be engaged to conduct this installation.

It is also recommended to install electronic timers or humidity sensor type switches for both bathroom exhaust fans in the house. These fans should be run during showers or baths and for at least 15 minutes after or until humidity clears from windows and mirrors. Fans, grills, and components should also be cleaned on a regular basis. For further
