# INSPECTION REPORT

For the Property at:  
**000 ANY STREET**  
ANYTOWN, MB

RE: Report No. 2041  
000 Any Street  
Anytown, MB

Multi-family Pre-purchase Inspection

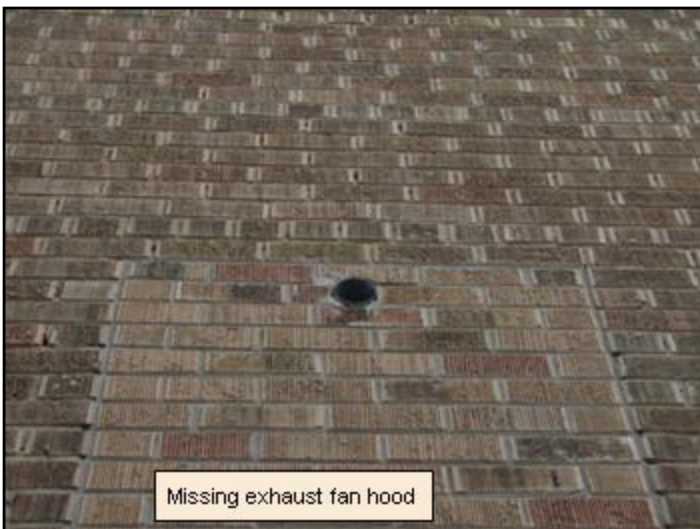
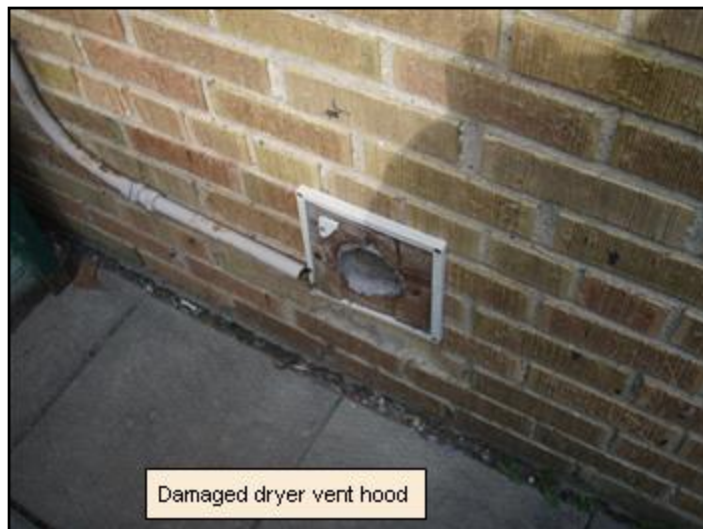
**Location:** Various Exterior Wall

• Replace missing damaged dryer and exhaust fan hoods as required. Recommend using aluminium type with dampers.

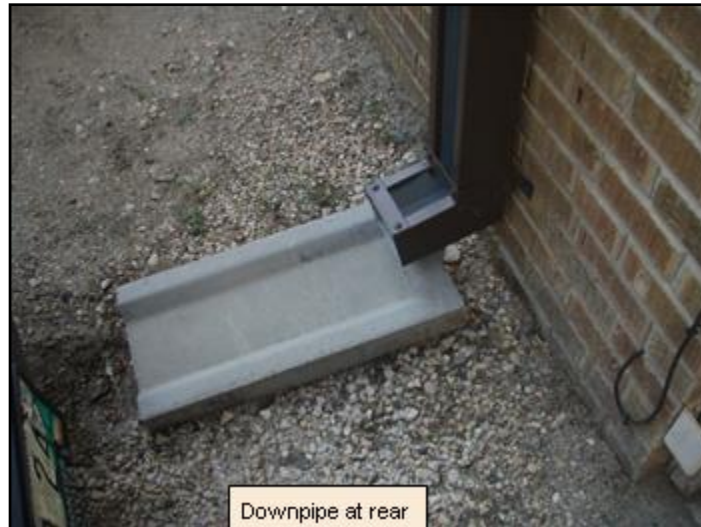
**Location:** Rear Exterior

**Condition:** • Downspouts end too close to building

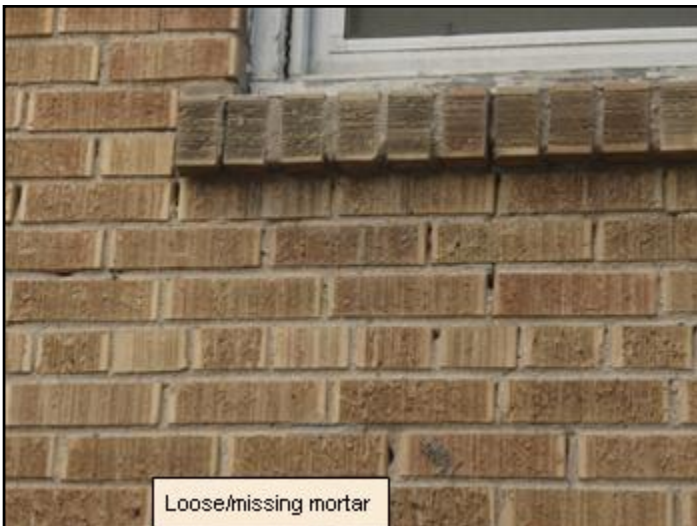
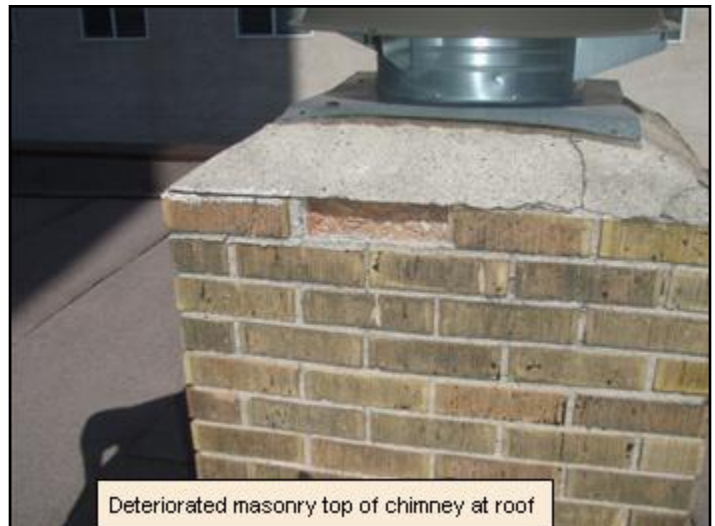
**Location:** Various Exterior Wall

**Condition:** • Masonry deterioration

Some masonry/mortar deterioration observed various areas around building, recommend repair/repointing as required. This is a major cost item, recommend consulting with a masonry contractor for repair costs.

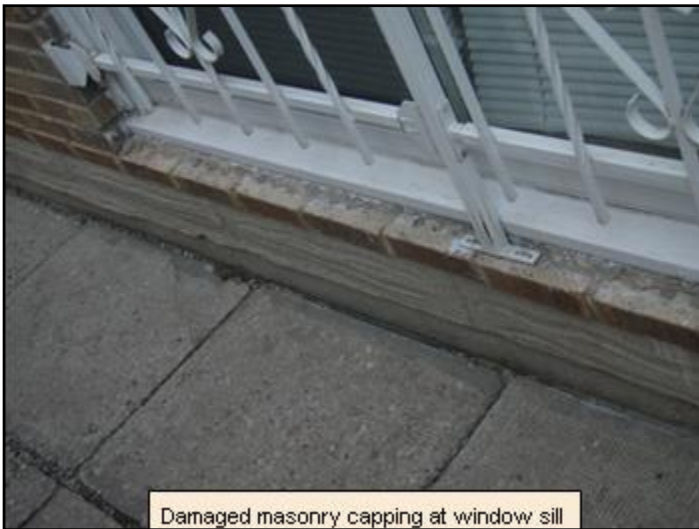
Damaged masonry capping at window sill

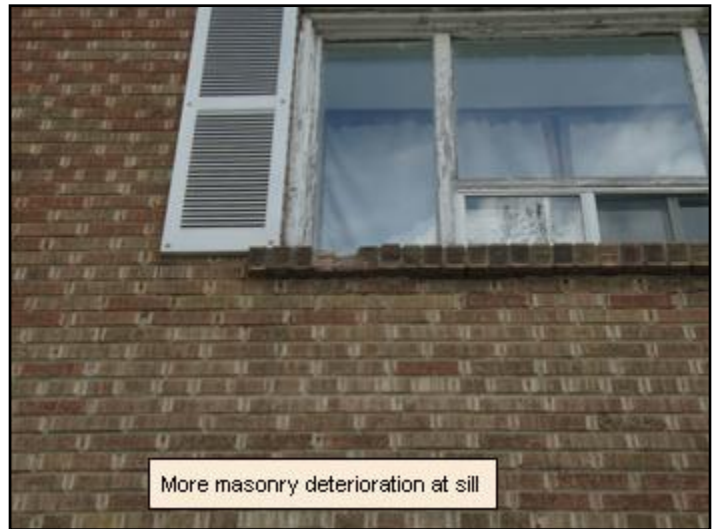
More masonry deterioration at sill

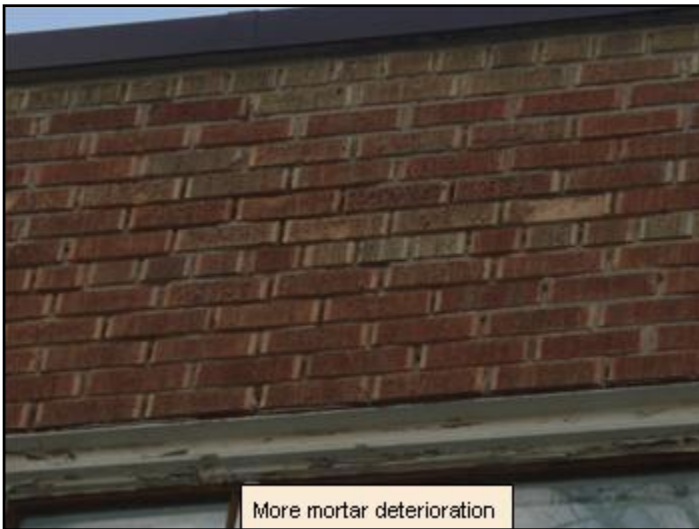
More mortar deterioration

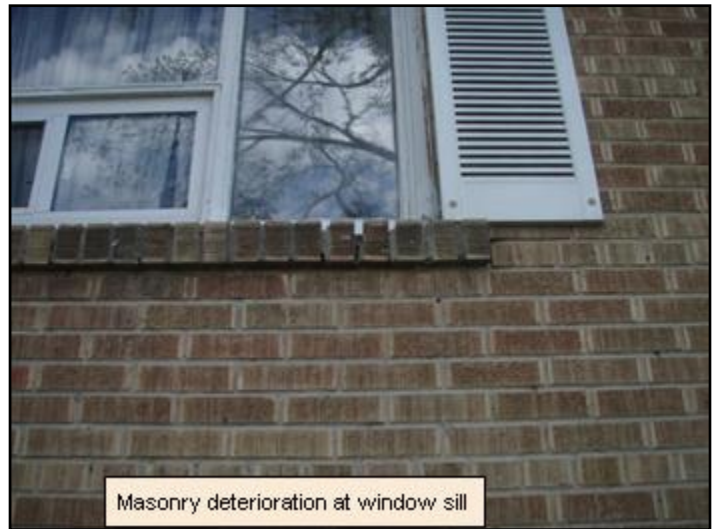
Masonry deterioration at window sill

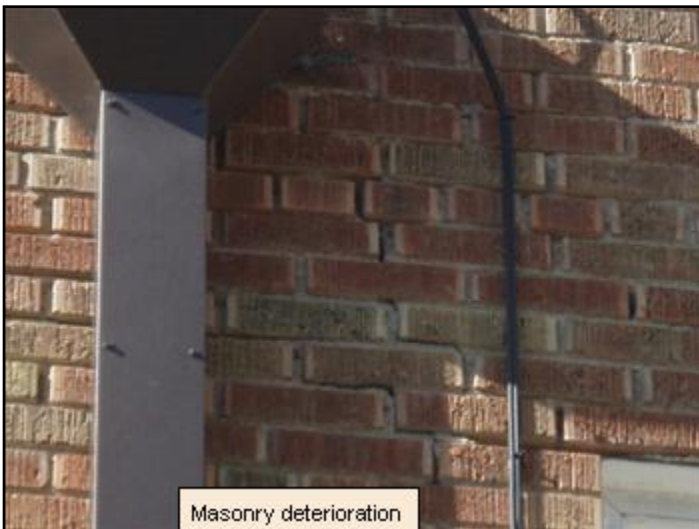
Masonry deterioration

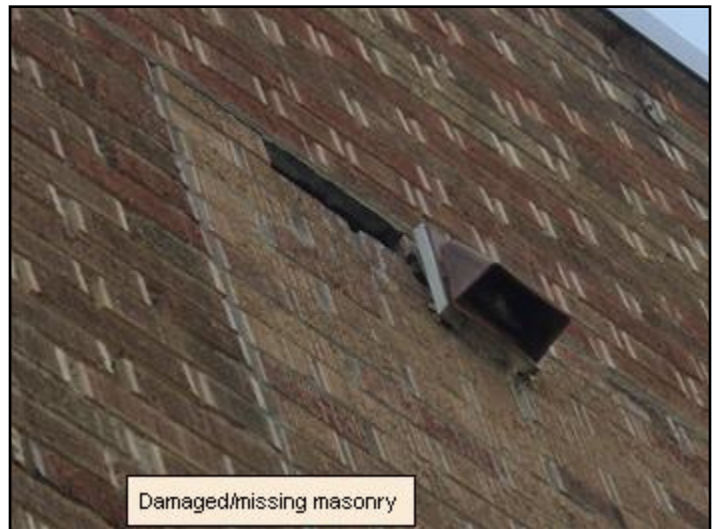
Damaged/missing masonry

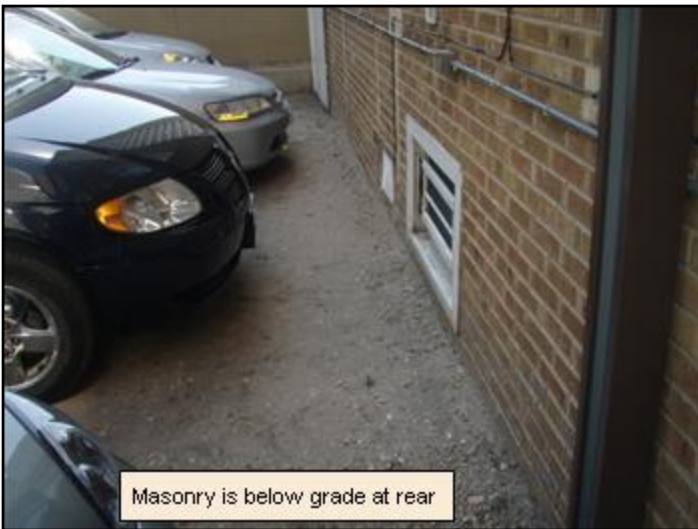
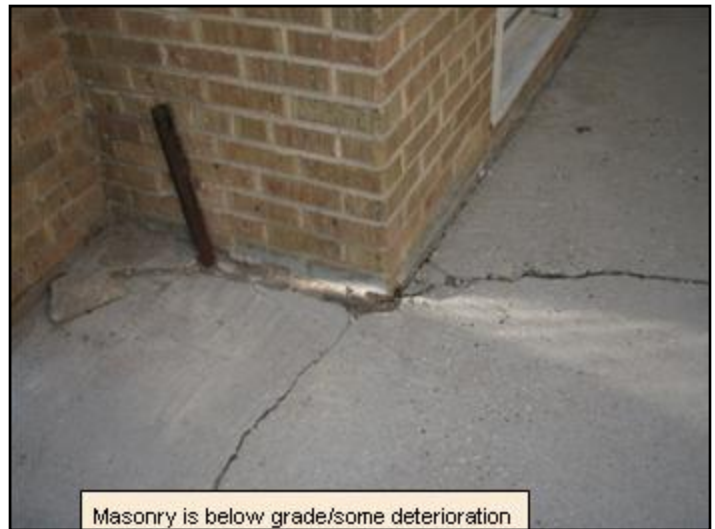
**Location:** Rear & West

**Condition:** • Too close to grade

Bricks are below grade at rear and west side. This is not recommended as masonry can deteriorate with moisture and freeze/thaw cycles. It is recommended to monitor brick, lower grade if possible and still maintain proper slope from building. If this is not possible proper flashings should be installed at lower portions of wall, inset into mortar joint to reduce moisture damage to masonry.

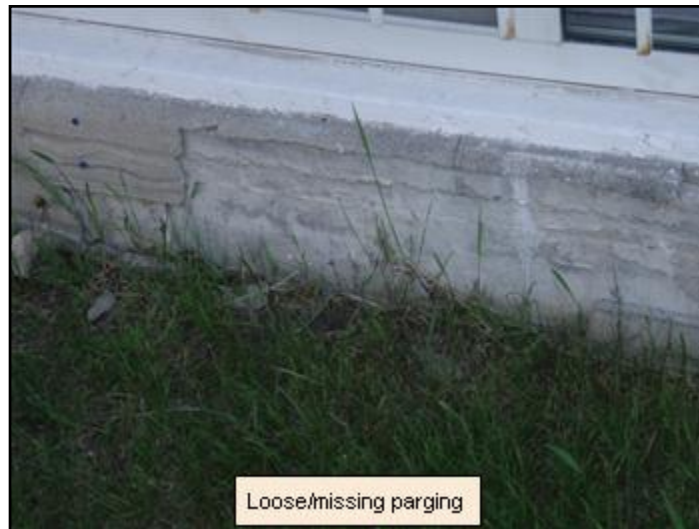
**Location:** Various Exterior

**Condition:** • Parging damaged or missing

Recommend repairing parging when repairing masonry.

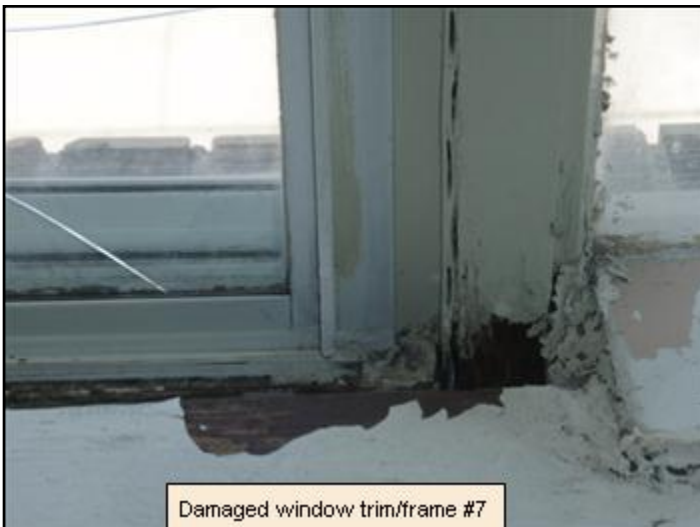
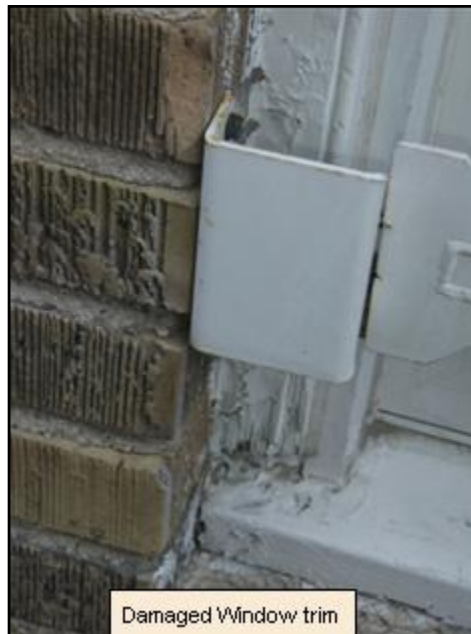
**Location:** Various Exterior

**Condition:** • Window trim moisture damaged, repair/replace as required. When replacing windows recommend replacing entire frame, vinyl is recommended.

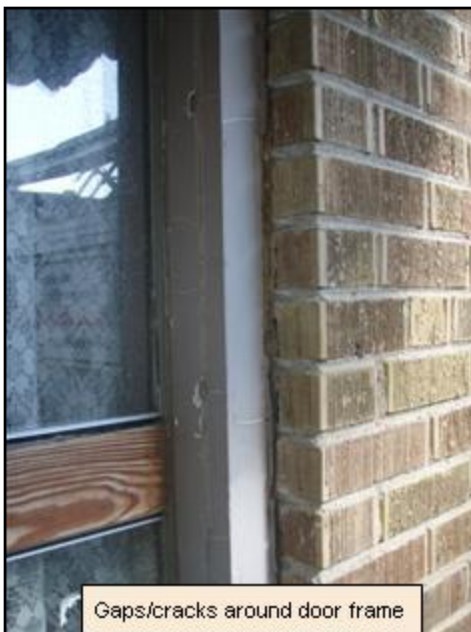
**Location:** Throughout Exterior

**Condition:** • Caulking missing, loose or deteriorated

Recommend improving caulking around window frames and doors following mortar/masonry repairs.

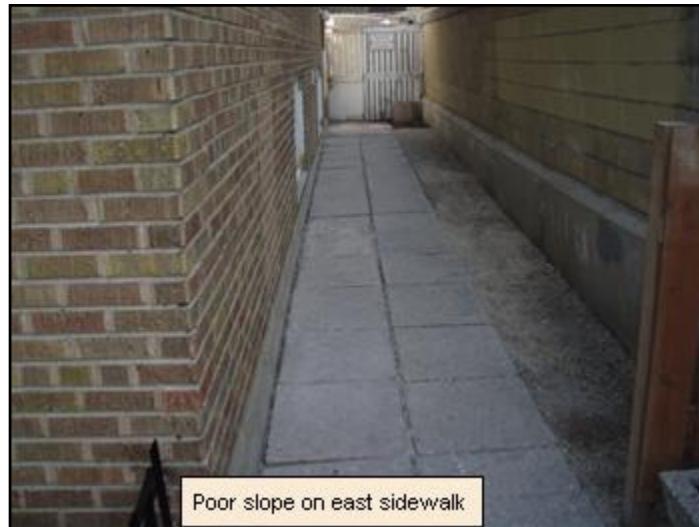
**Location:** East Exterior

**Condition:** • Improper slope or drainage

Walkway should slope away from building to reduce moisture at foundation.

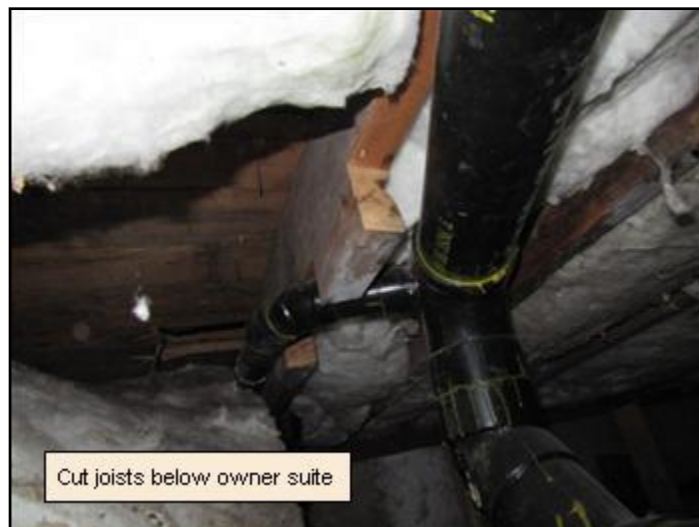
**Condition:** • Joists have been cut to accommodate plumbing in owners suite crawlspace, repair as required.

Cut joists below owner suite

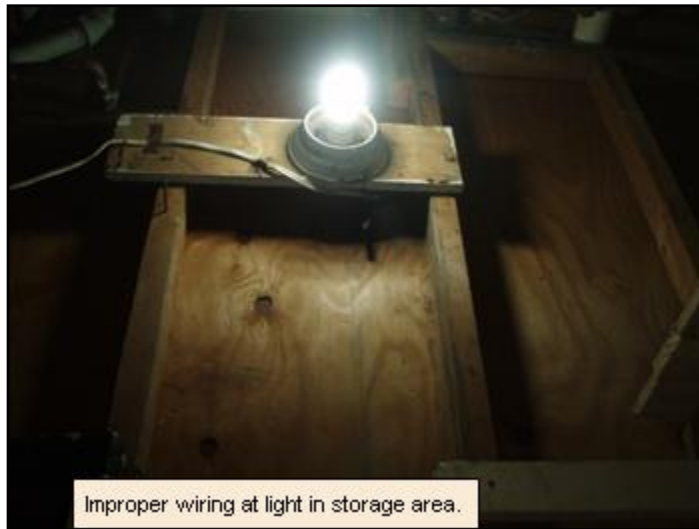
**Location:** Basement

**Condition:** • Open splices

Open joints at light in storage area, all joints should be in electrical boxes, repair as required.

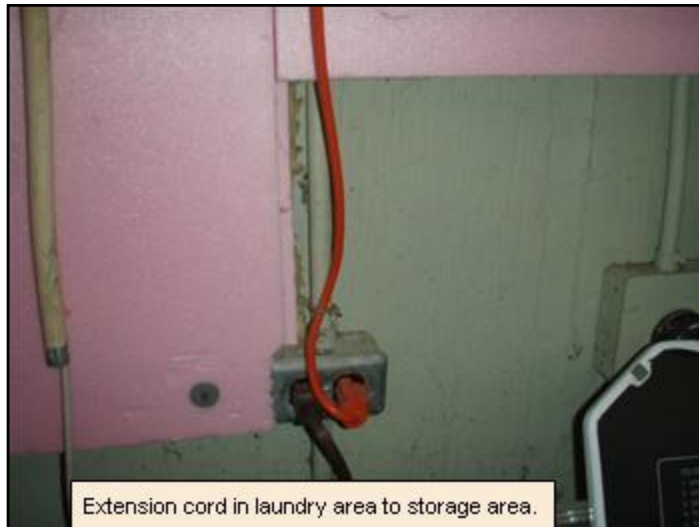
**Location:** Basement Laundry Area

**Condition:** • Extension cord used as permanent wiring

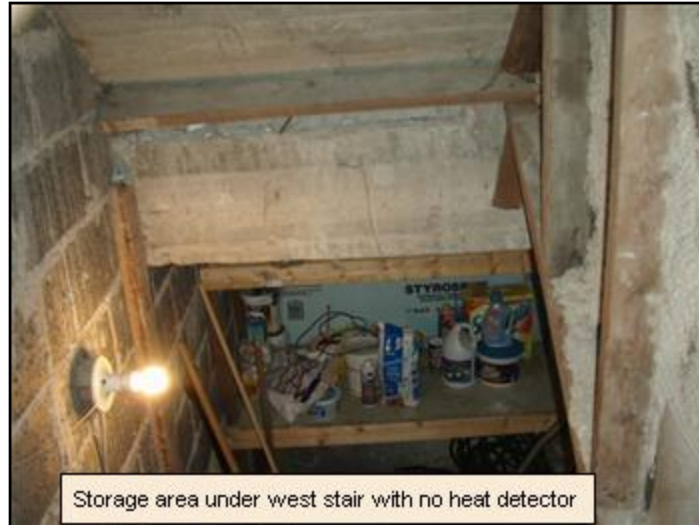
**Location:** Basement Staircase

**Condition:** • Install fire alarm heat detector in storage room under west stair as this area is used as storage room.

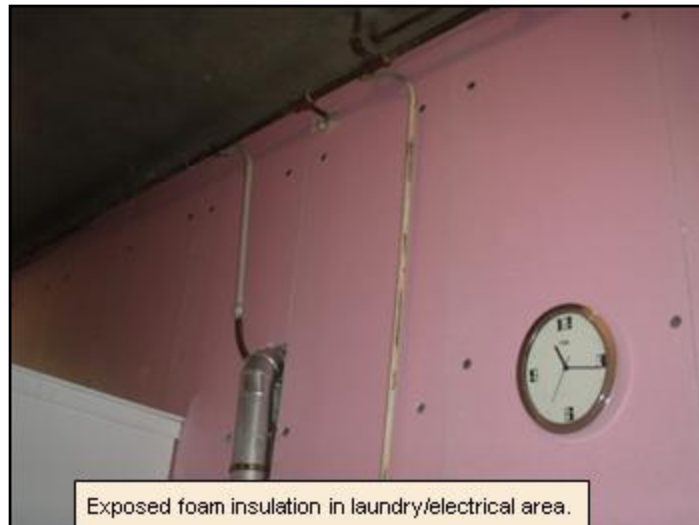
**Location:** Basement Laundry Area

**Condition:** • Exposed combustible insulation

Cover exposed foam insulation with drywall.

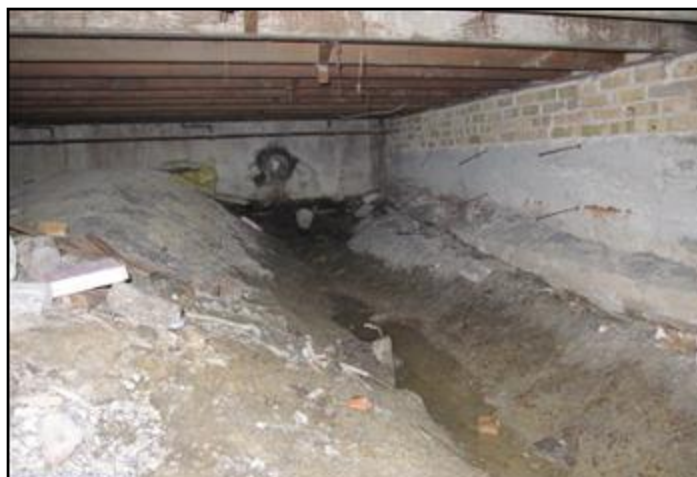
**Condition:** • Recommend engaging plumber to check main water supply and sewer line in crawlspace to determine if there are plumbing leaks causing or contributing to moisture in crawlspace.

Water pooling right crawlspace. Copper water line running along this area

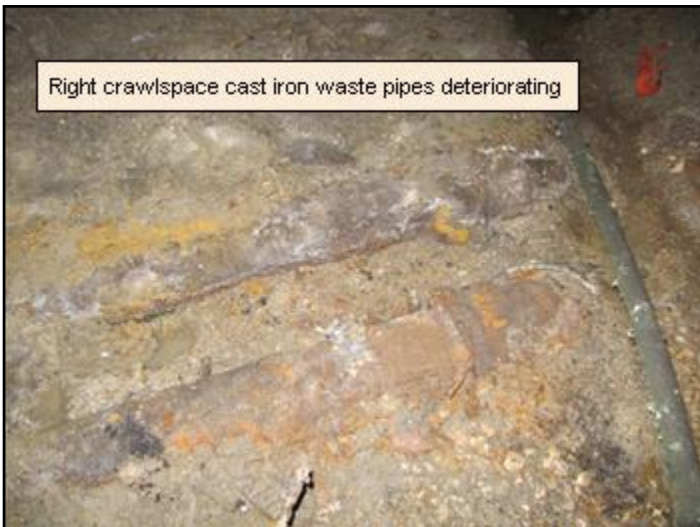
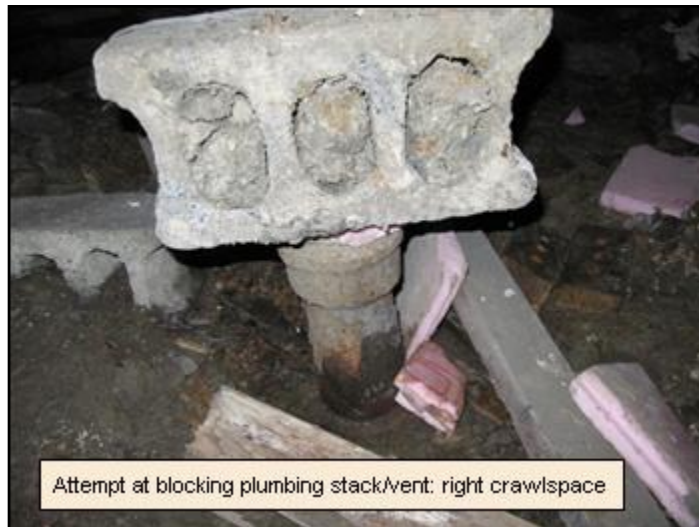
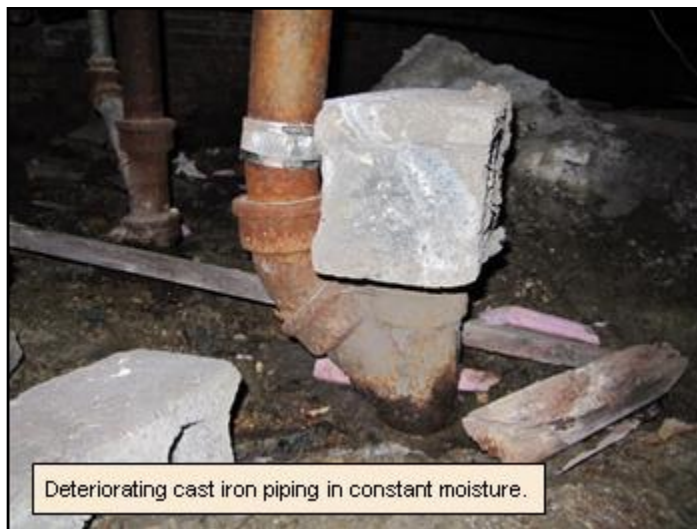
**Location:** Crawl Space

**Condition:** • Rust

Waste plumbing in crawlspace is very rusted due to ongoing moisture. Drain pipe in crawlspace requires proper capping.

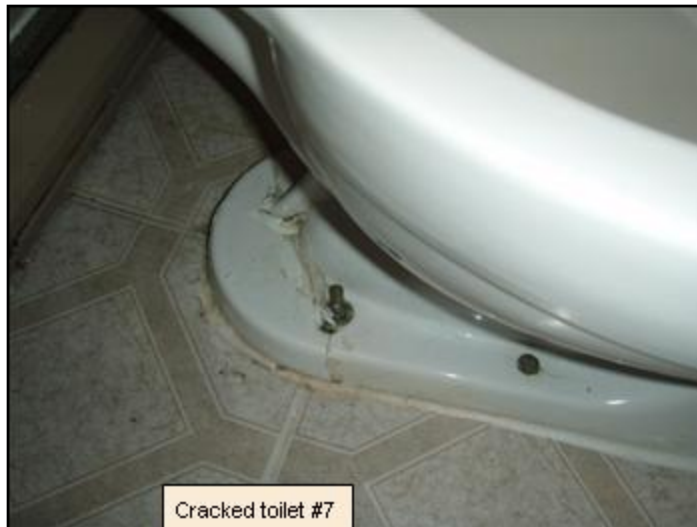
**Location:** #7

**Condition:** • Replace cracked toilet.

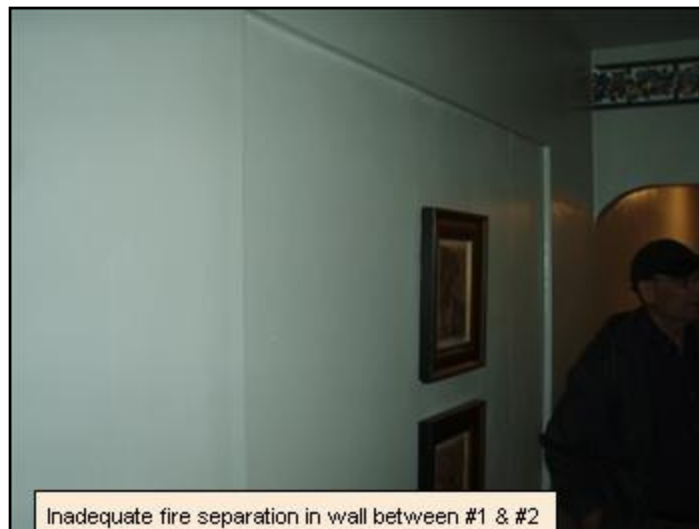
**Location:** Suite 1 and 2

**Condition:** • Suite to suite fire separation has been compromised due to installation of doors to join suites. Recommend repairing to restore fire separation or install fire rated doors and frames.

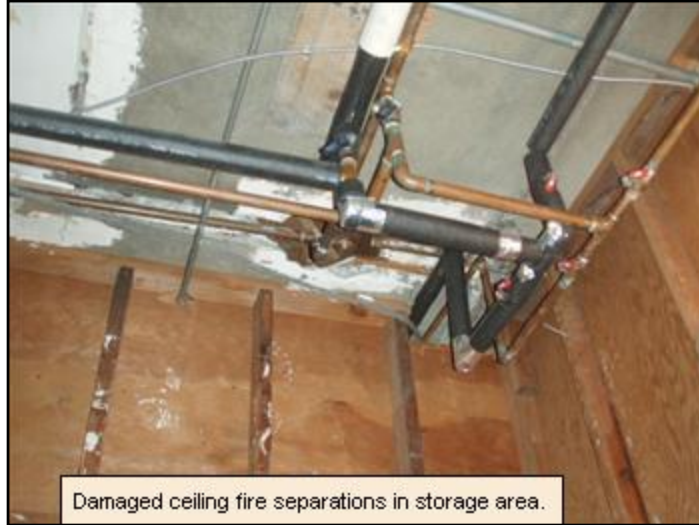
**Location:** Basement

**Condition:** • Repair damaged ceiling fire separation in basement storage area.

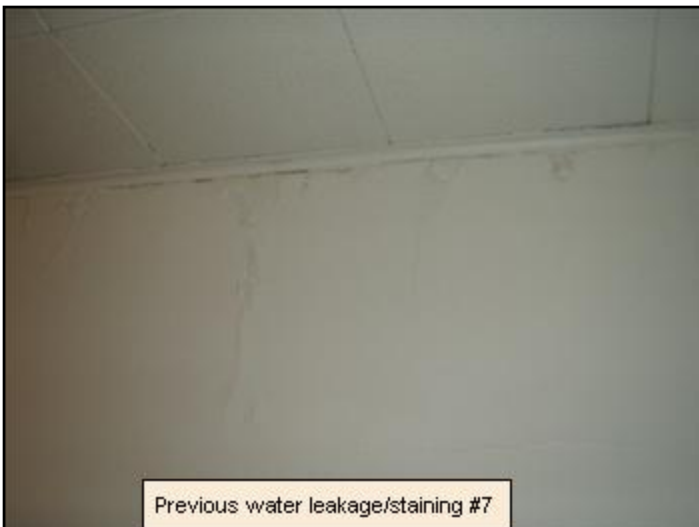
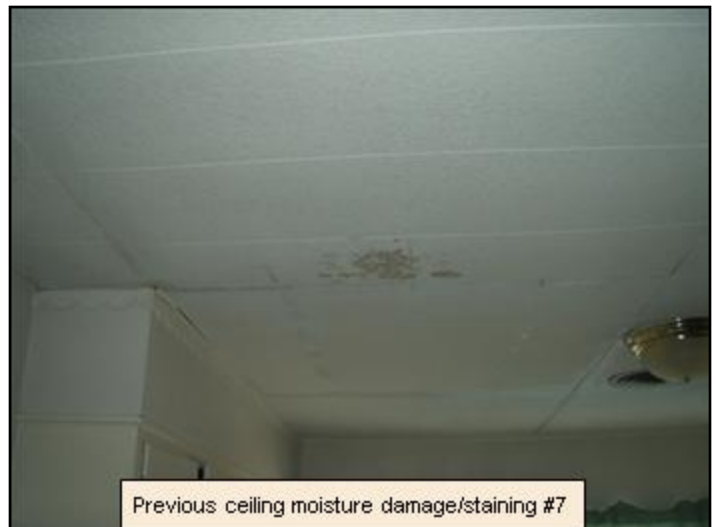
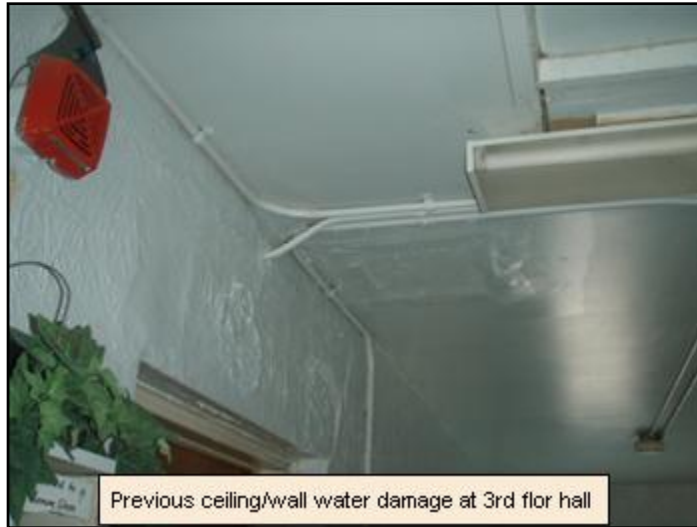
**Location:** Third Floor Hall, #7

**Condition:** • Water damage

Ceiling previously water damaged from roof leakage, monitor.

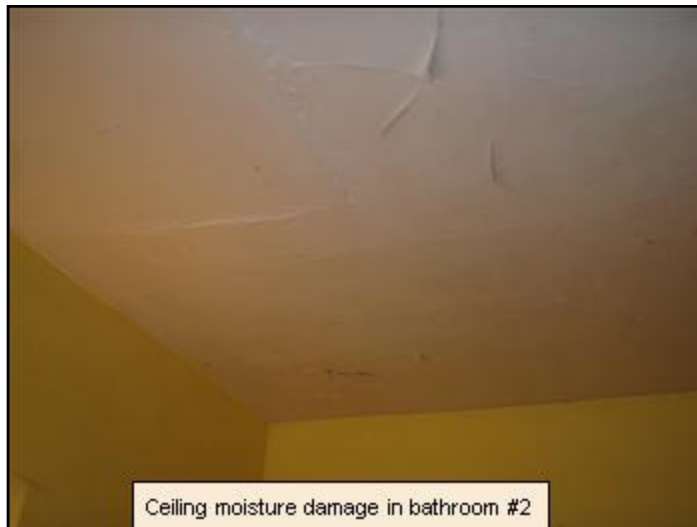
**Condition:** • Water damage

Repair damage ceiling finish in #2 bathroom, repair exhaust fans as recommended to improve fan performance.

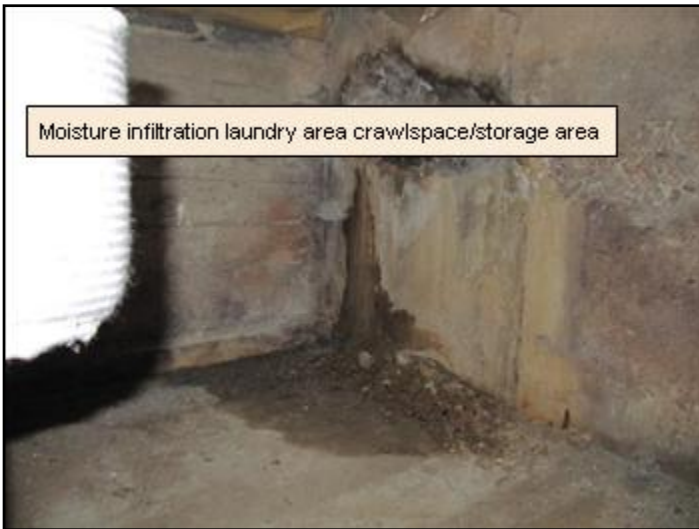
Moisture infiltration laundry area crawlspace/storage area

Improve grade at rear and east side to reduce/limit leakage to crawlspace.

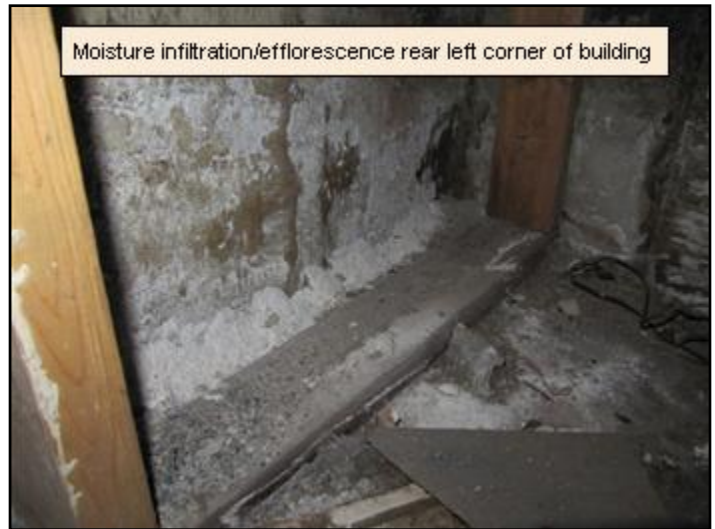
Moisture infiltration/efflorescence rear left corner of building

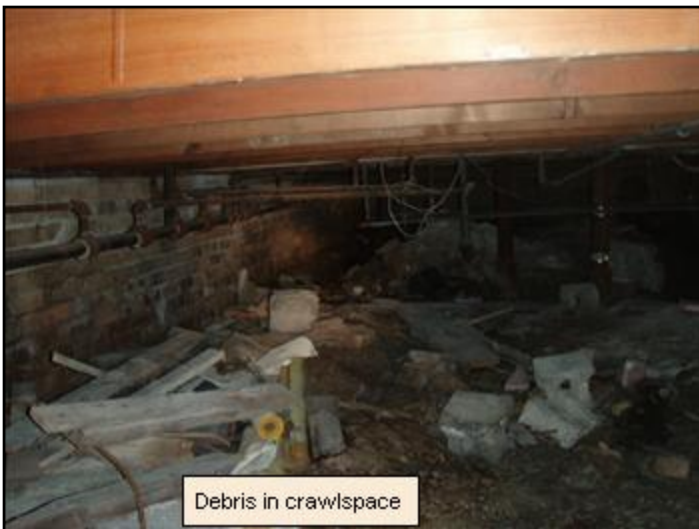
Debris in crawlspace

In order to better drain moisture from crawlspace, it is recommended to install interior drainage system around foundation footings and pipe to a least one sump pit . This will assist in draining water entering and seeping into crawlspace on a continuous basis. There should also be a pump installed in pit and piped to drain to building exterior, well away from building. The crawlspace should be cleaned of all debris after which a 6 mil poly should be installed on ground in crawlspace. The poly should be sealed to foundation walls and at all joint overlaps. This work should be done by foundation repair specialist. This is also a major cost item.

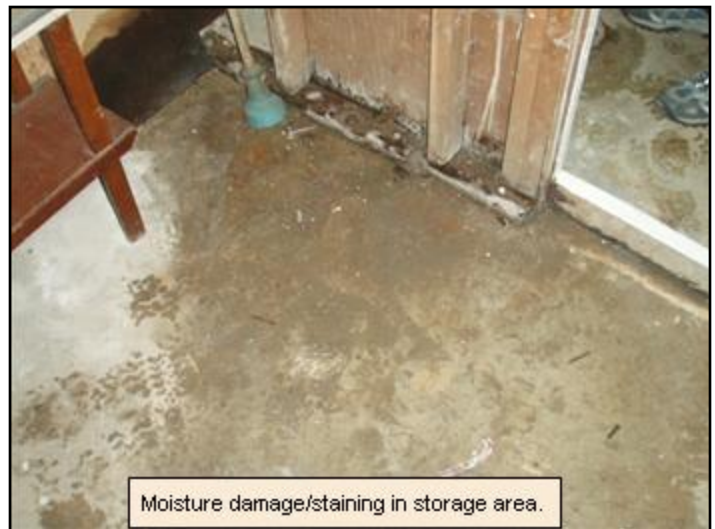
Moisture damage/staining in storage area.

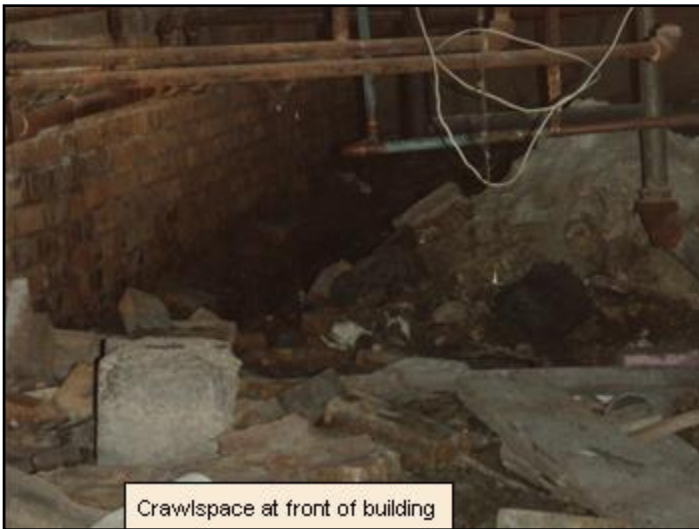
Crawlspace at front of building

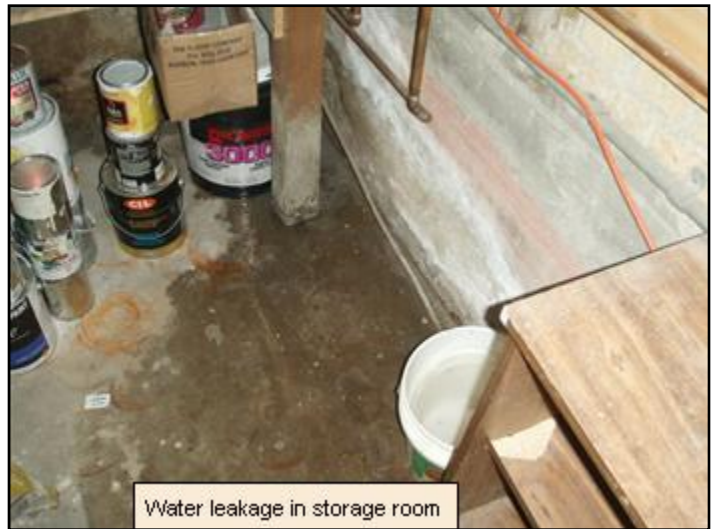
Water leakage in storage room

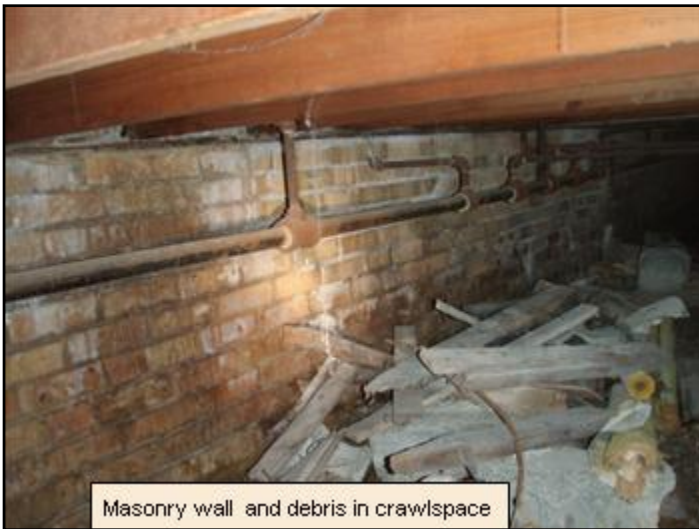
Masonry wall and debris in crawlspace

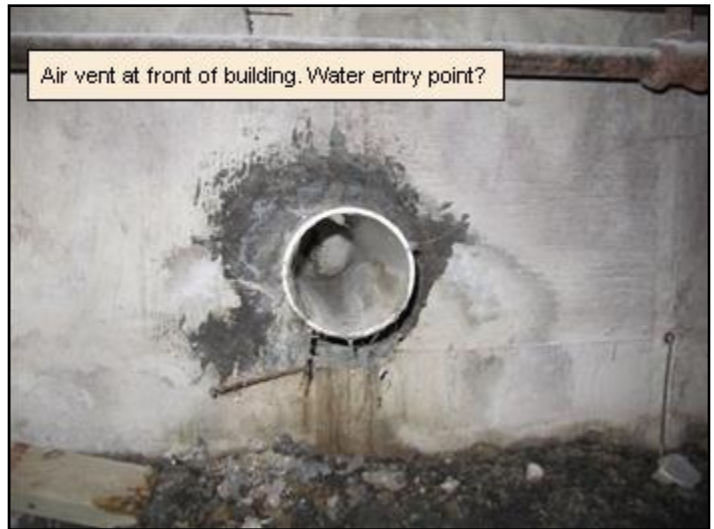
Air vent at front of building. Water entry point?

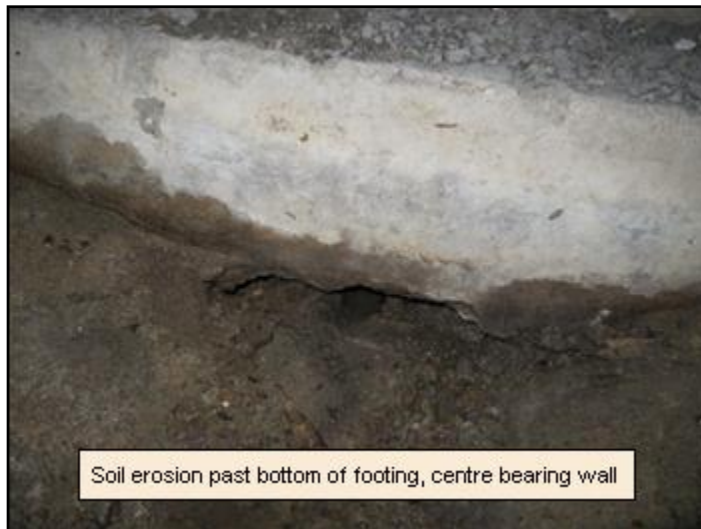
Soil erosion past bottom of footing, centre bearing wall

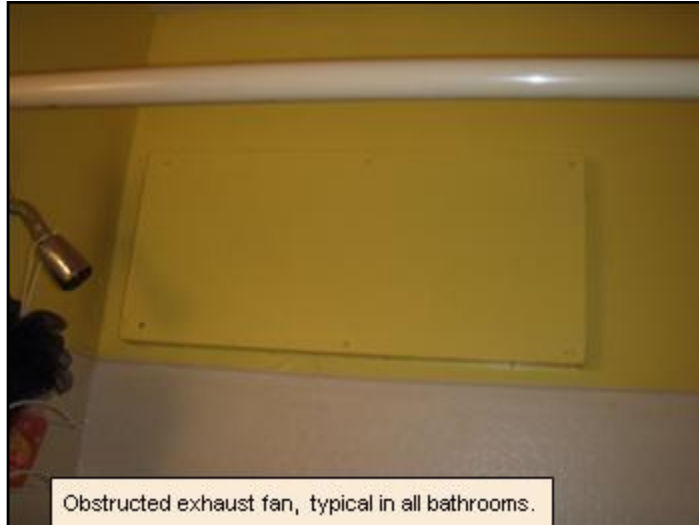
**Location:** All Bathrooms.

**Condition:** • Inadequate air movement

Bathroom fan performance is inadequate with solid wood in front. Recommend installing proper grilles.

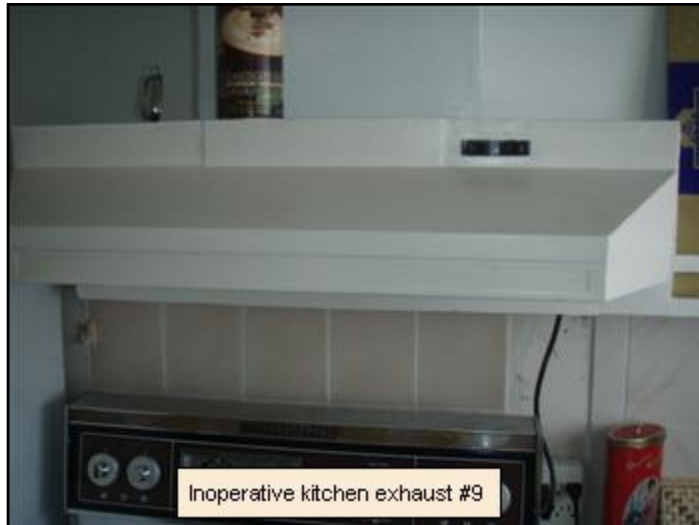
**Location:** #9,

**Condition:** • Blower inoperative
