# INSPECTION REPORT

For the Property at:  
**000 ANYWHERE**  
ANYTOWN, MB

Prepared for: HOUSE REVIEW CLIENT  
Inspection Date: Monday, April 1, 2013  
Prepared by: Roger Chamberland, RHI, CMI

RE: Report No. 1504  
000 Anywhere  
Anytown, MB

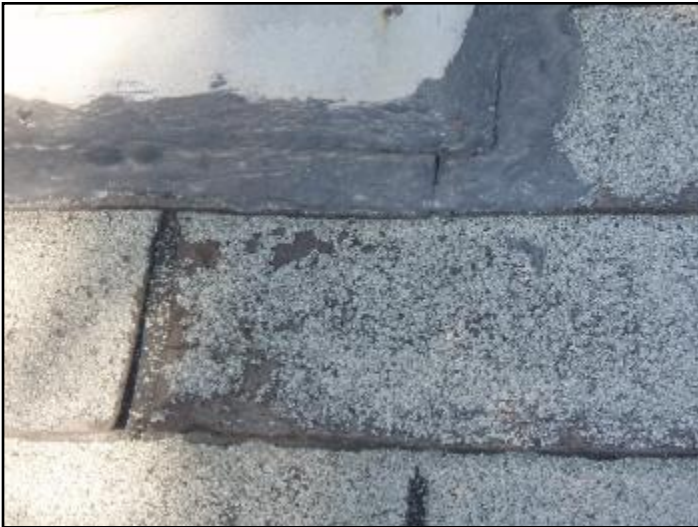
**Condition:** • [Near end of life expectancy](#)

Old, worn out

Cupping, curling, clawing

Granule loss

Missing, loose or torn

*Garage roof at chimney*

**Task:** Replace

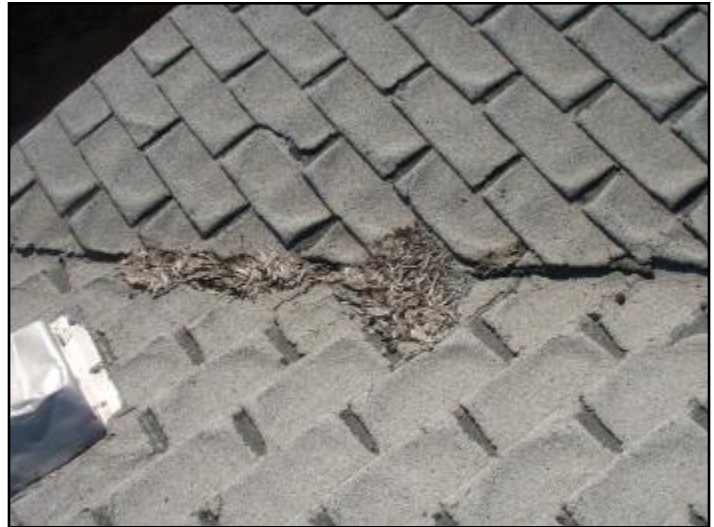
*House roof south valley*

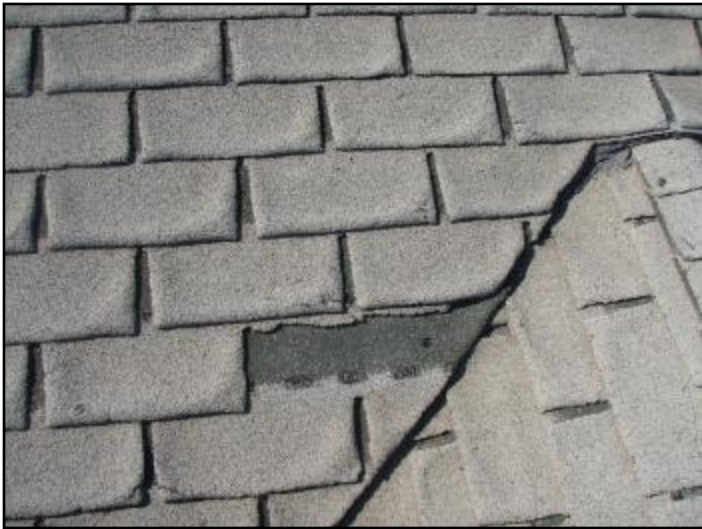
*Damaged/missing shingles*

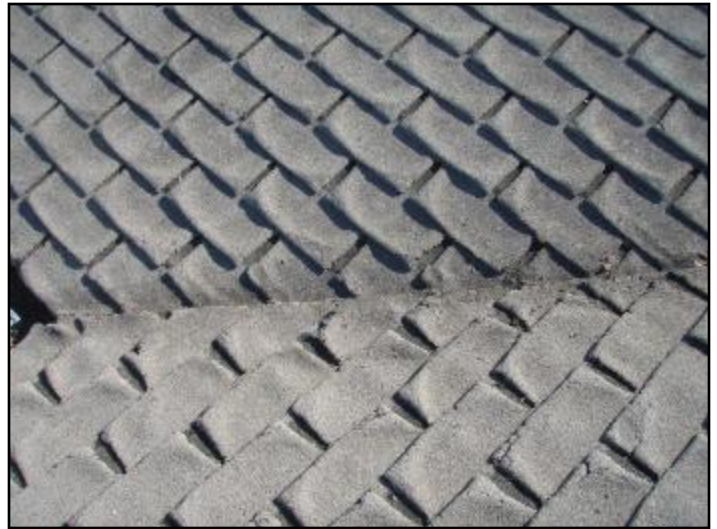
*House roof north valley*

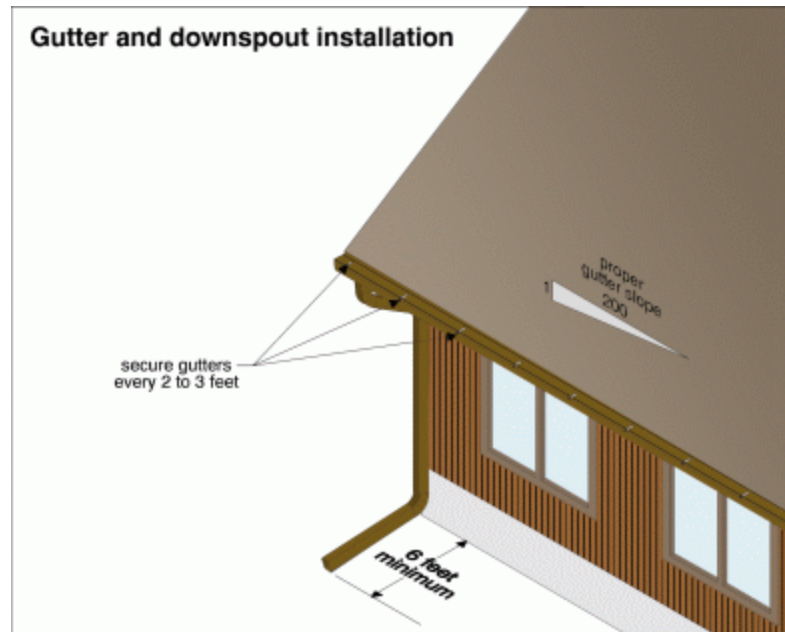
**Condition:** • [Missing](#)

**Location:** Garage

**Task:** Provide

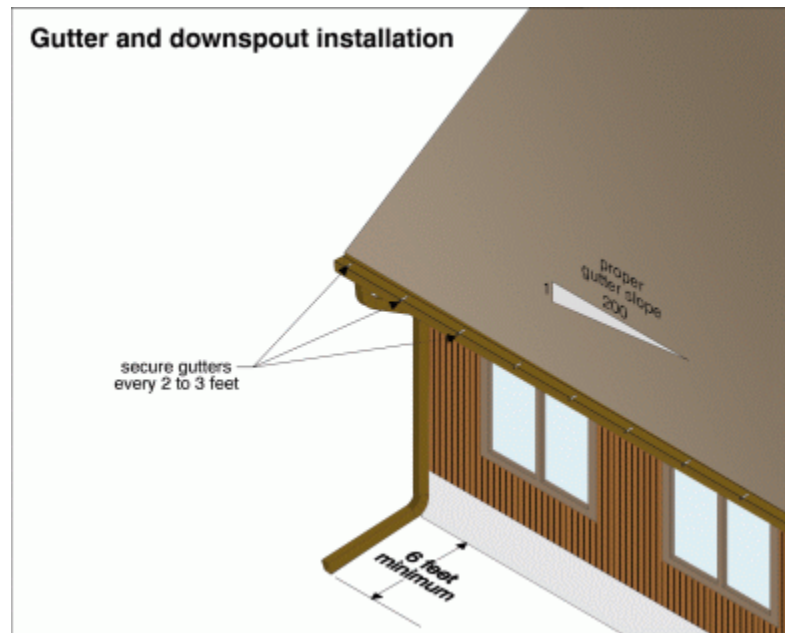
**Condition:** • [Downspouts end too close to building](#)

**Location:** Various

**Task:** Improve

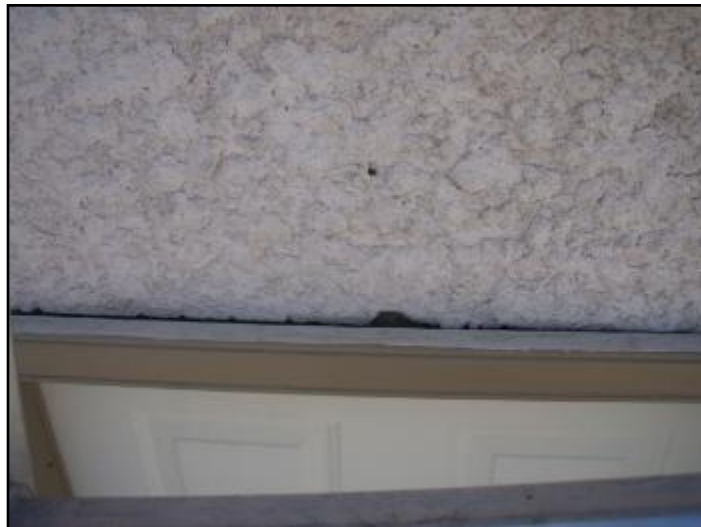
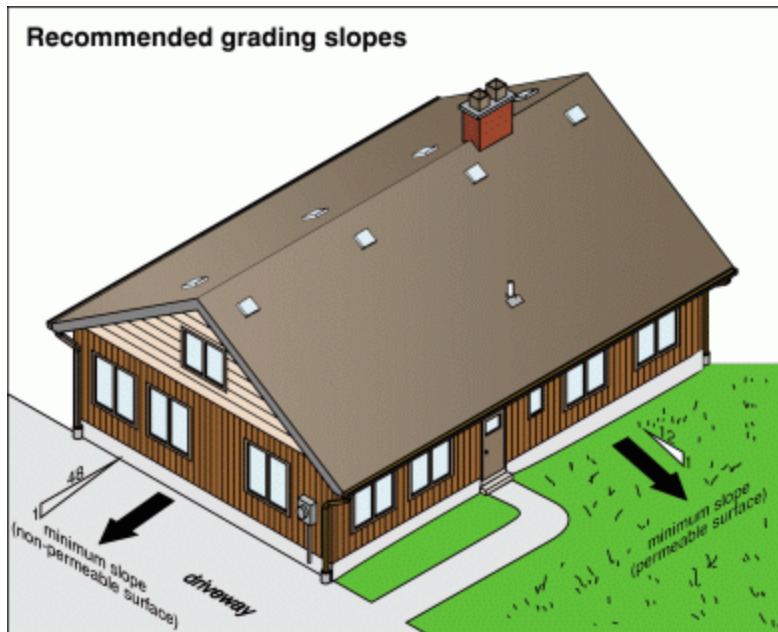
**Condition:** • [Improper slope](#)

**Location:** Various

**Task:** Improve

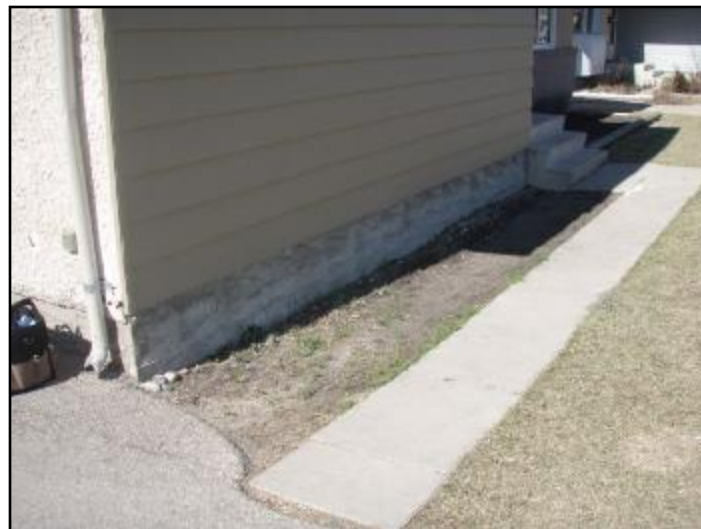
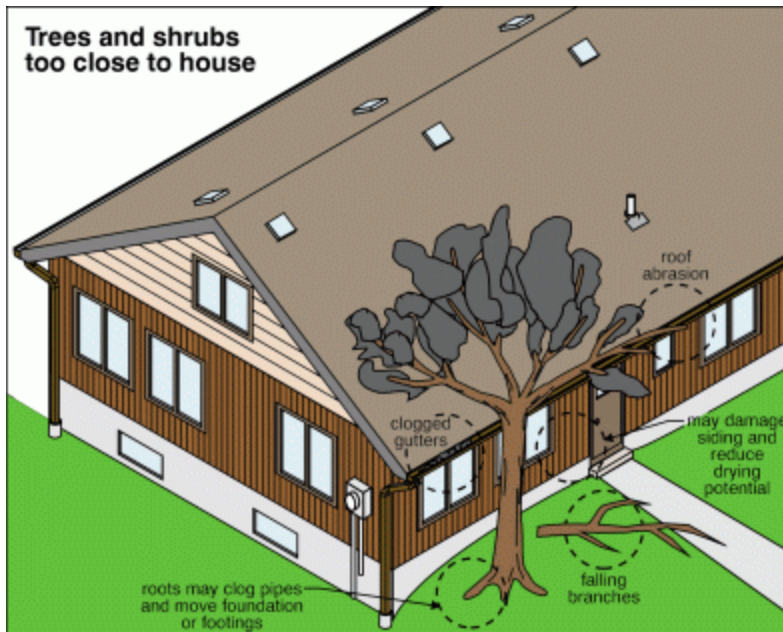
**Condition:** • [Trees or shrubs too close to house](#)

**Location:** Exterior

**Task:** Correct

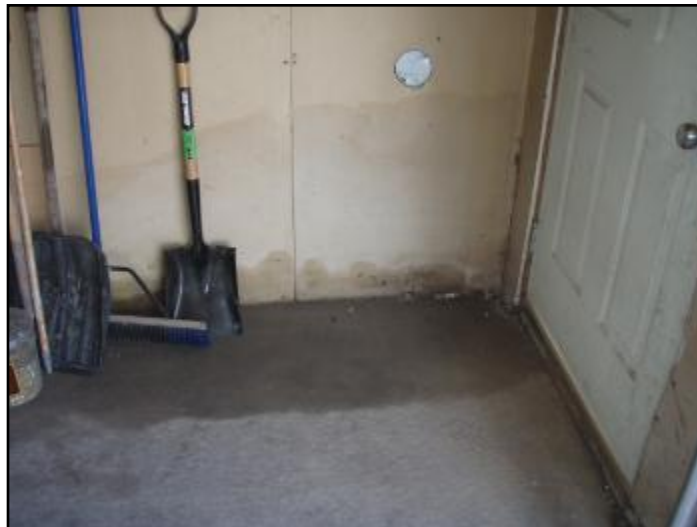
**Condition:** • Some moisture damage to drywall and framing, probably due to water pooling to northeast corner.

**Location:** Garage

**Task:** Monitor/Repair as required

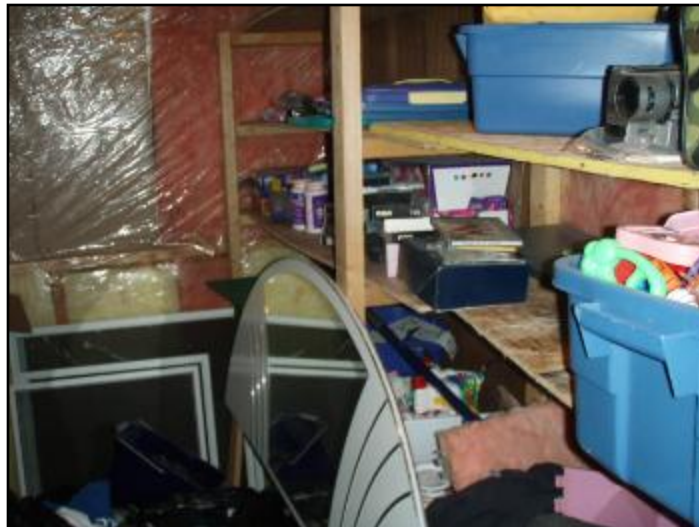
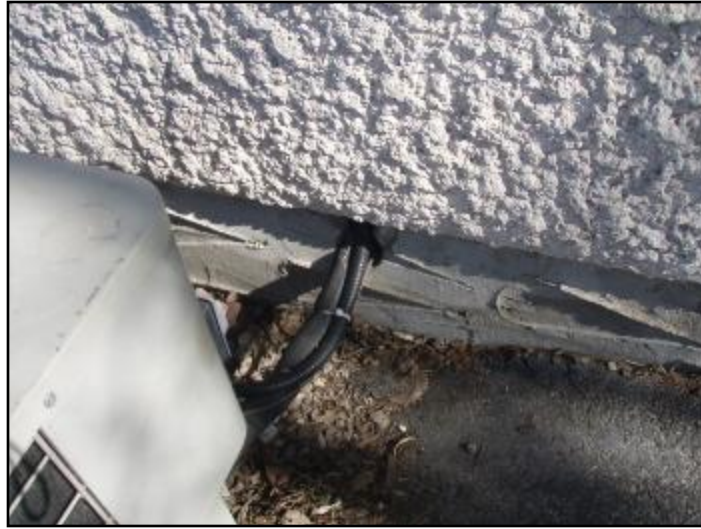
**Condition:** • Repair hole in foundation at A/C lines.

**Location:** West

**Task:** Repair

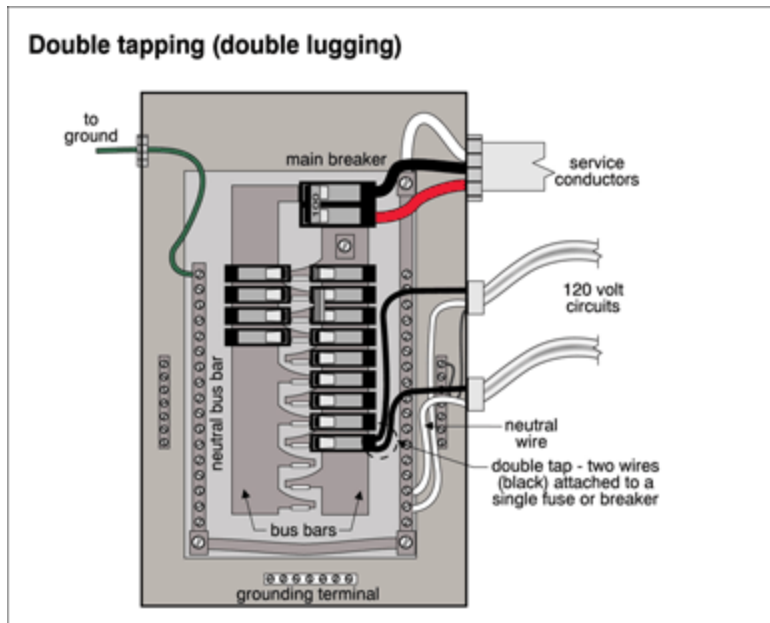
**Condition:** • [Double taps](#)

**Location:** Basement Utility room

**Task:** Correct

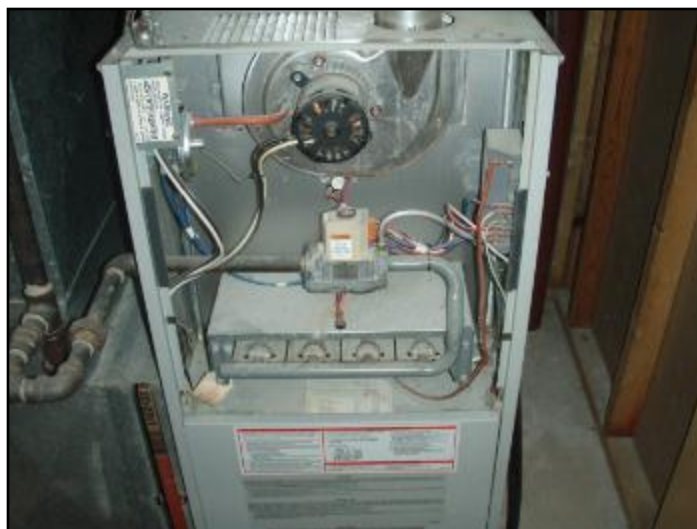
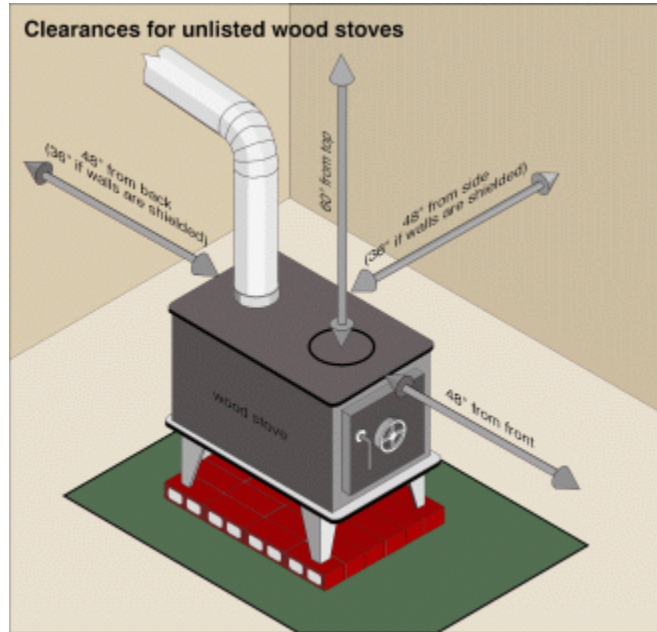
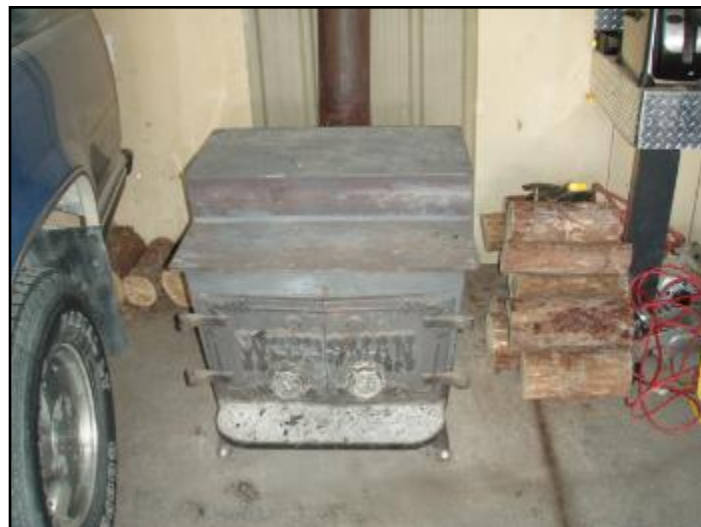
**Condition:** • [Side or back wall - combustible clearance inadequate](#)

Wood stove in garage, improper installation, do not use until evaluated and repaired.

Note; This appliance and installation may be an insurance issue.

**Location:** Garage

**Task:** Further evaluation/Repair/Remove

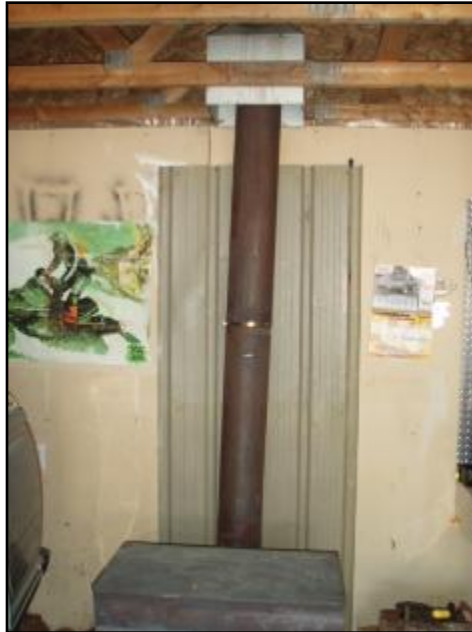
**Condition:** • [Combustible clearance](#)

**Location:** Garage

**Task:** Further evaluation

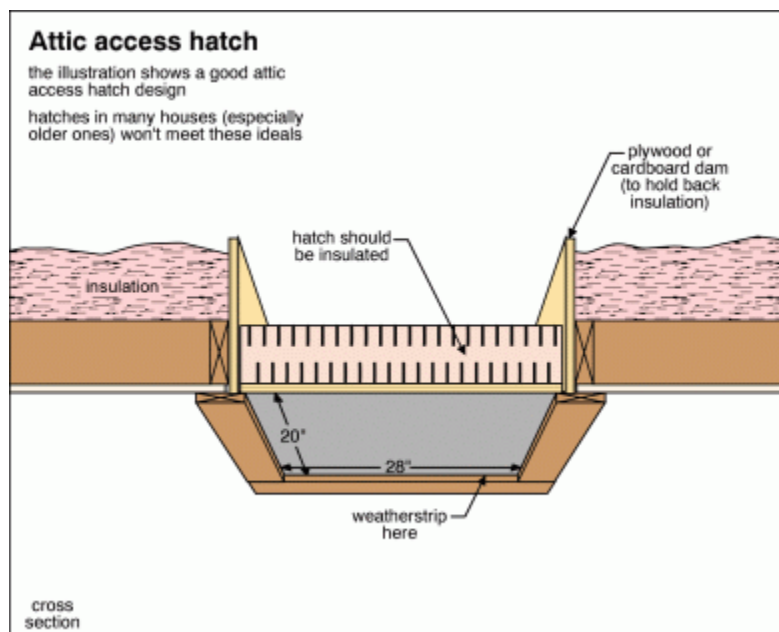
Condition: • [Not insulated and not weatherstripped](#)

Location: First floor Bedroom

Task: Improve
